EASTER INCH MOSS AND SEAFIELD LAW LOCAL NATURE RESERVE

Hydrological Survey

Ironside Farrar Ltd
52 Grovewood Business Centre
Strathclyde Business Park
Bellshill
ML4 3NQ

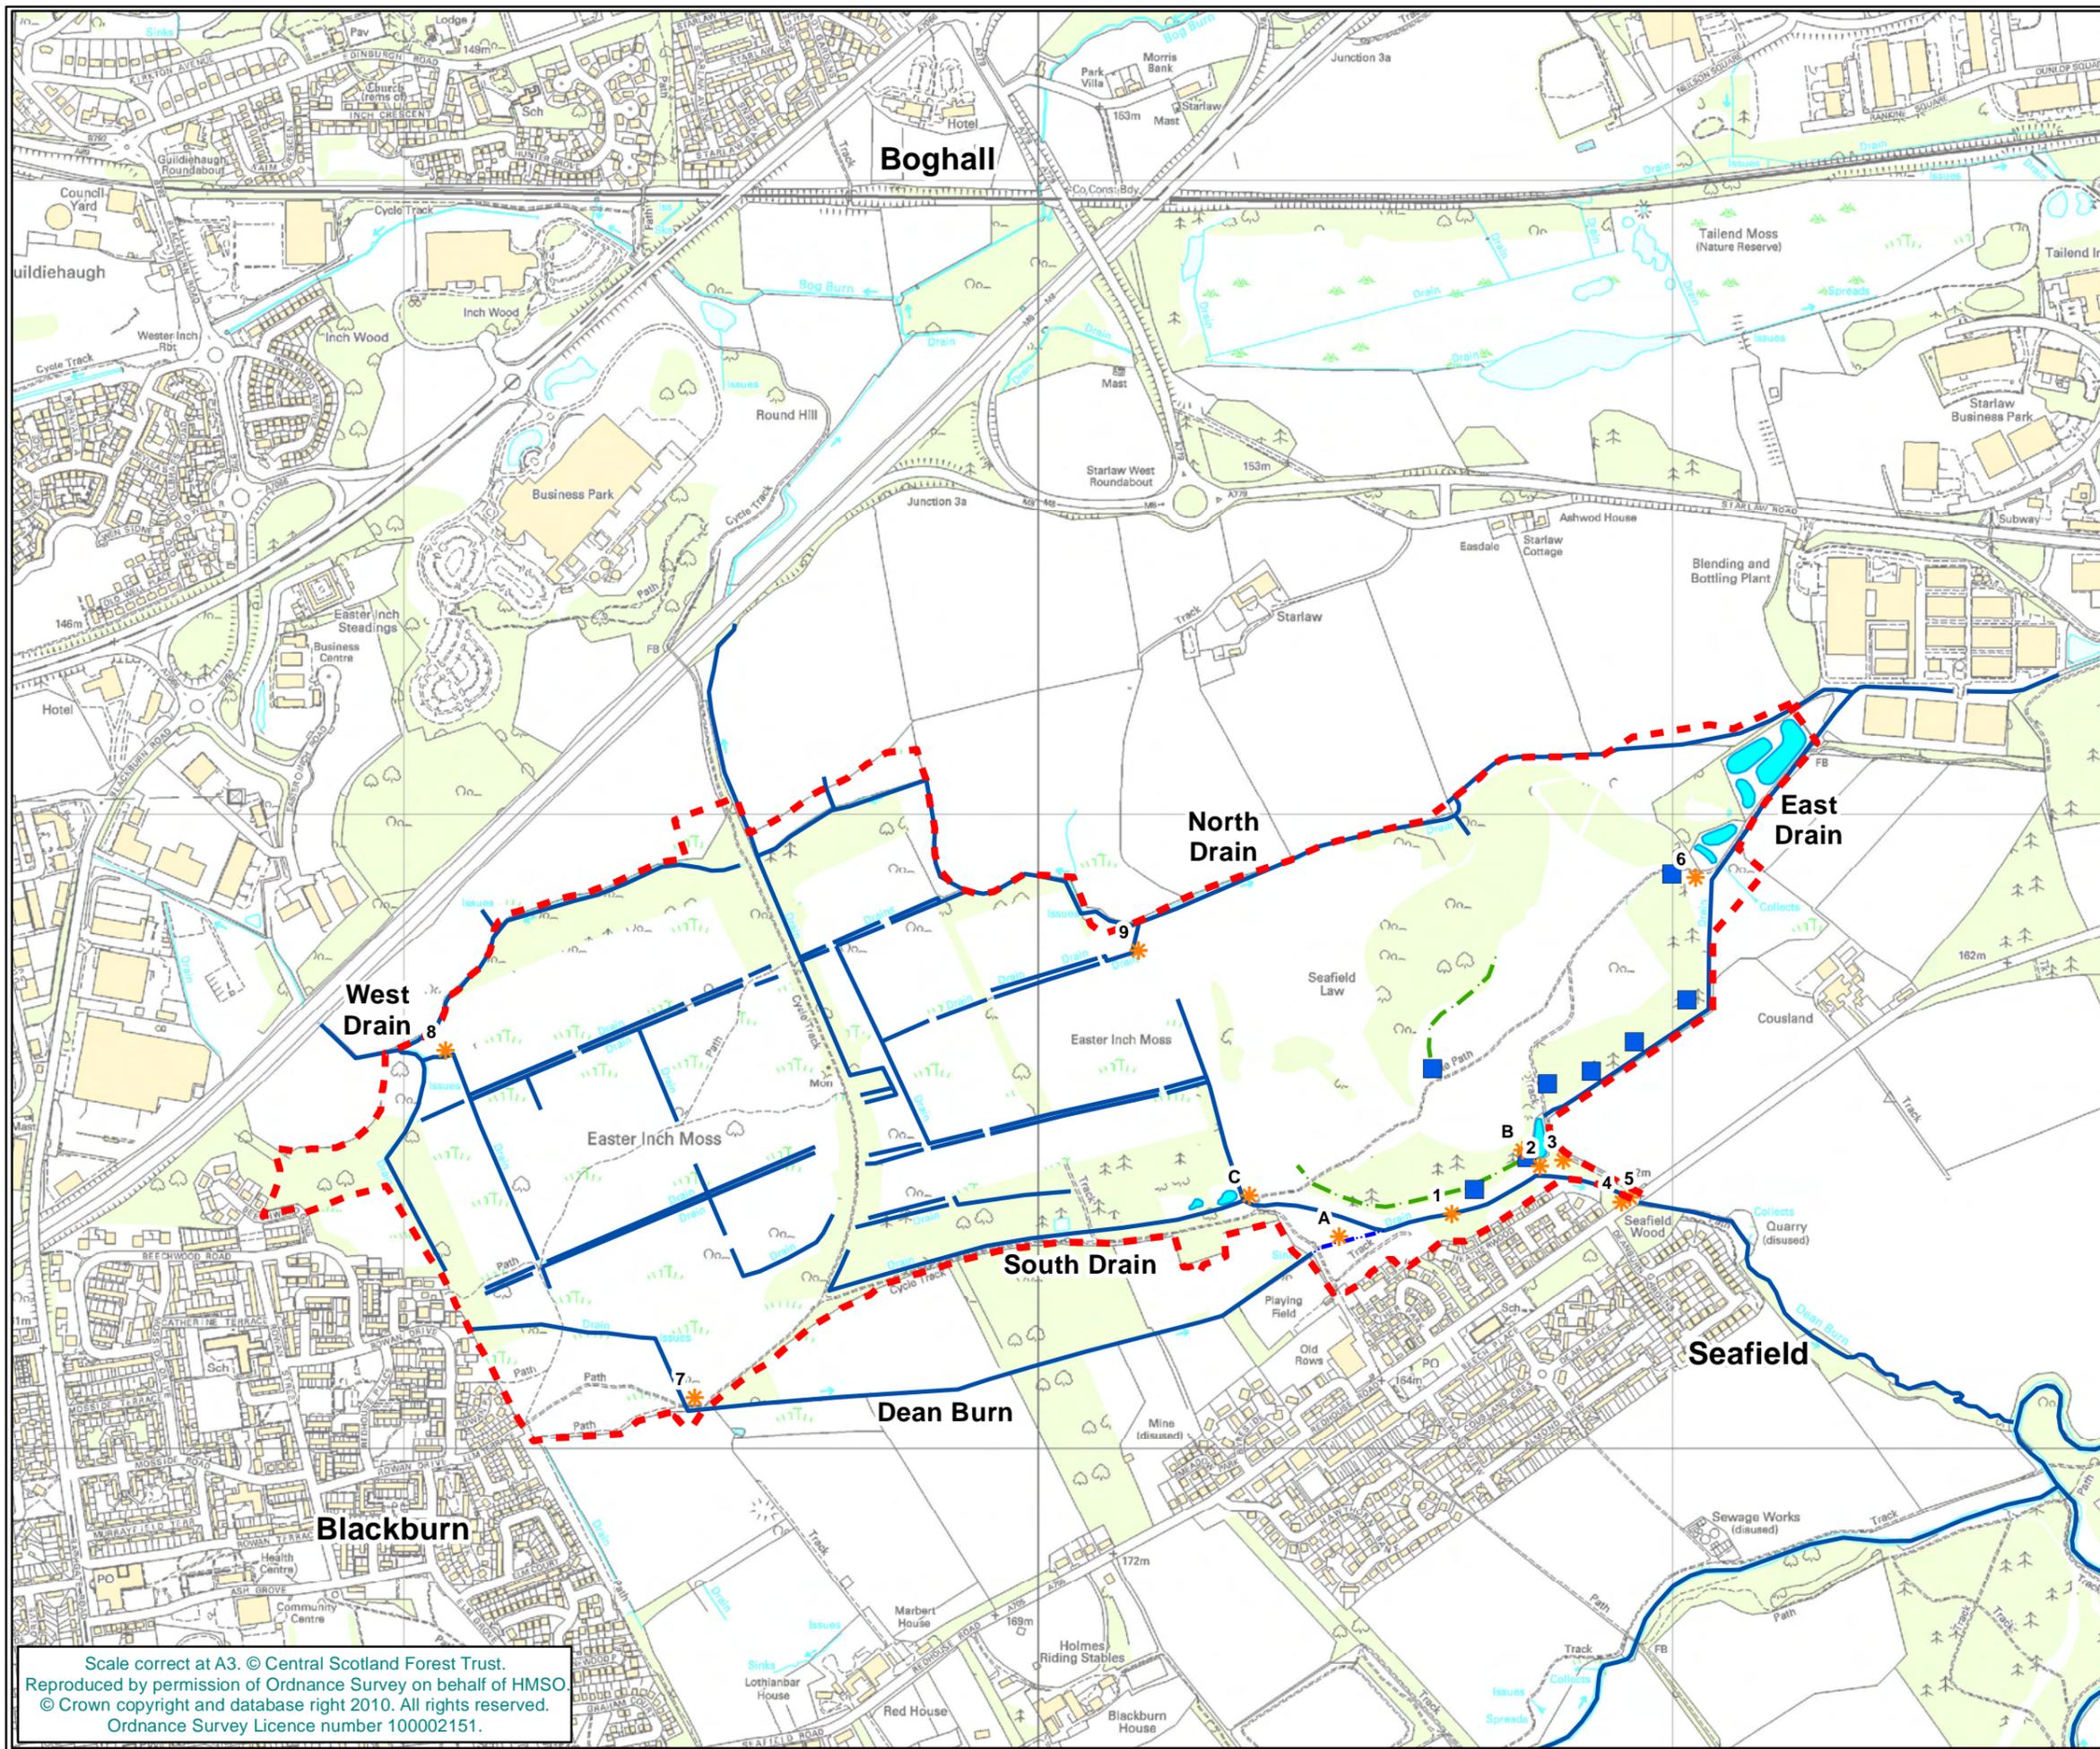
Dwg No 4467_401

The main hydrological features are identified in Drawing No. 4467/401 and referred to below:

A 300 mm diameter concrete pipe outfalls into the Burn. This was not running during the inspection but it appears to originate from the nearby Heather Park Waste Water Pumping Station. It is assumed this is an emergency overflow to the Dean Burn. Given this is a Local Nature Reserve it is recommended that Scottish Water be consulted on the frequency and nature of any discharge from the WWPS to review whether this is impacting adversely on the watercourse.

A 150 mm diameter outfall was noted at the southern end of the middle pond. It is assumed this is a simple overflow device for the pond, however, no records were available to confirm this. Scour from the outfall has resulted in some pipe sections collapsing. This is obviously progressing towards the pond and remedial works are recommended to prevent a breach of the pond or undermining of its perimeter fence.

A redundant septic tank was recorded adjacent to the Burn which presumably overflows to the Burn. The tank had no cover during the inspection. We would recommend that the cover be replaced or the tank removed / infilled as a matter of urgency.

A small diameter pipe outfalls to the Burn close to the A705. This sort of pipe is normally associated with fresh water and it is likely that this is an overflow from the nearby Scottish Water scour valves on the main road. The pipe was not running during the inspection.

A 150 mm diameter plastic pipe outfall to the Burn close to the A705. It is assumed this is associated with local land drainage. The pipe was not running, however, minor scouring was noted around the outlet.

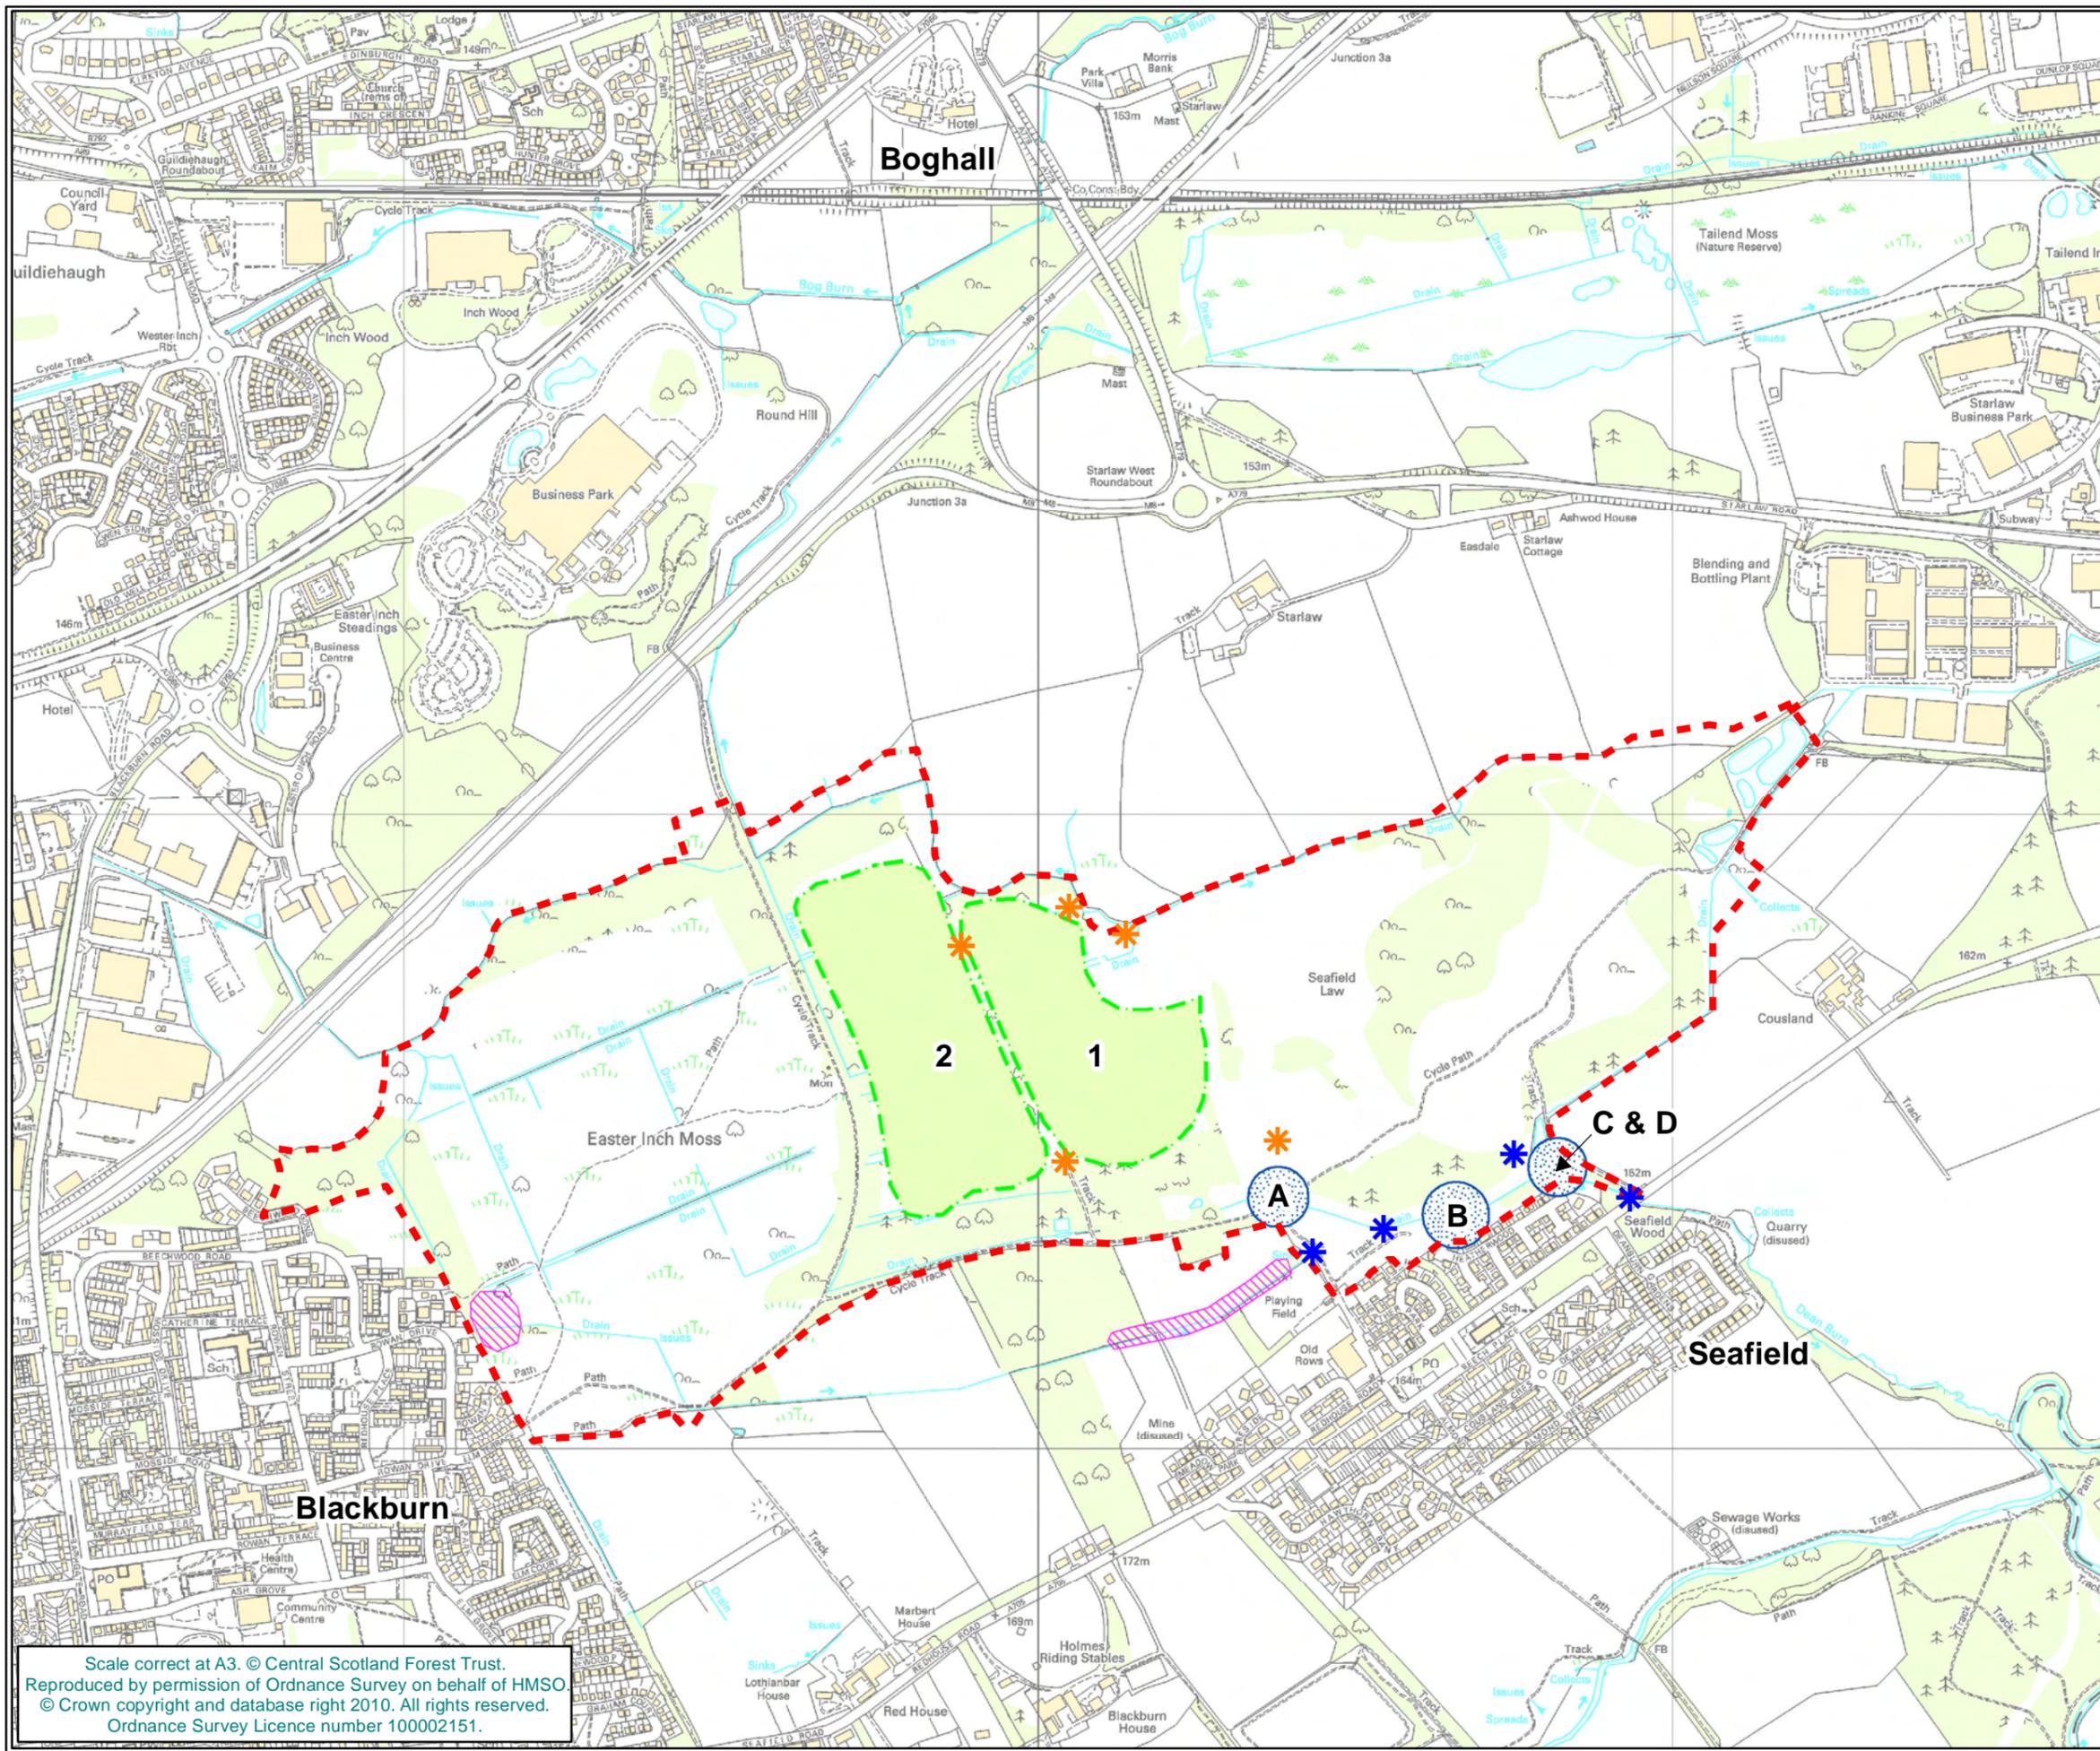
Dwg No 4467_402

Drawing 4467/402 shows a notional phasing boundary. Phase 1 area has been selected as it is closest to the existing unmodified raised bog and offers the best opportunity for success. This Phase 1 area can be further divided into at least 5 additional 'cells' each of which should be tackled incrementally.

We believe that the water table can be raised by blocking selected drains from the Moss. Given the access conditions we would suggest that locally felled trees could be used to dam the ditches fairly easily reinforced with locally sourced excavations. The felling operations would also assist in the bog restoration works. Notional locations for these dams are shown on Drawing 4467/402, however, we would recommend these are reviewed on site as works progress.

A - Improve Culvert / Pond Edge/ Path Crossing. Consider flow control

B - Review discharge from PS with Scottish Water.

C - Repair outfall.

D - Seal / remove Septic Tank
