Our ref: G2008/468A-02/PB/LM

18 December 2008

LAWRIGG ROAD, FAULDHOUSE

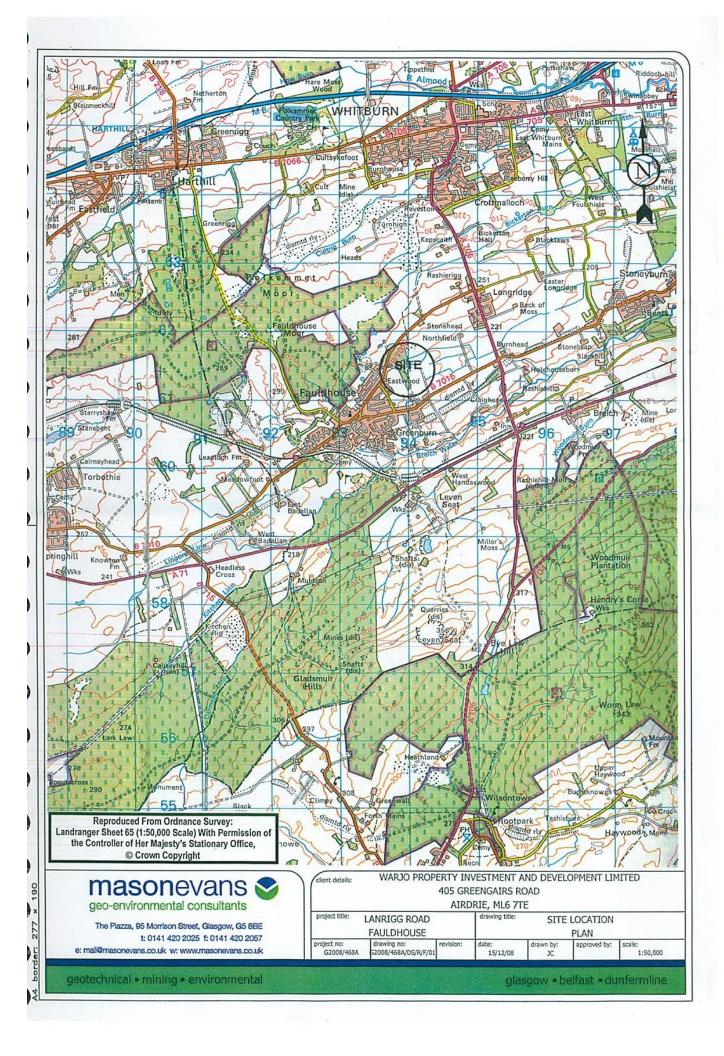
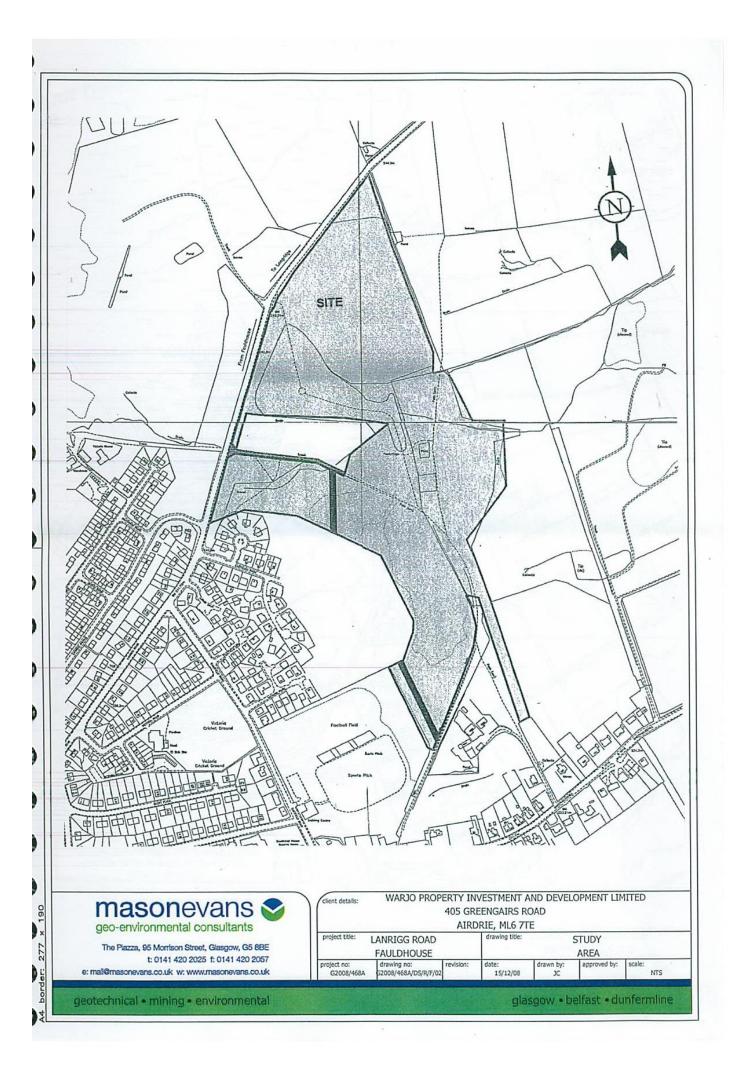
The site is located to the north east of Fauldhouse village with Lanrigg Road to the west (Drawing Nos G2008/468A/DS/F/01-02).

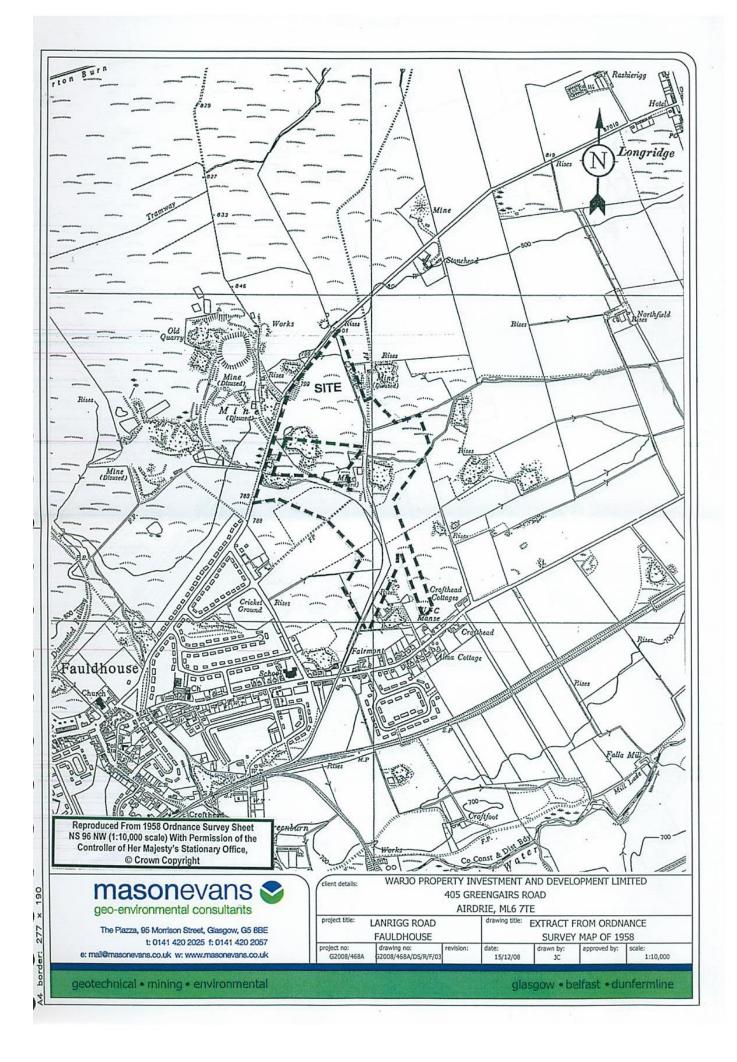
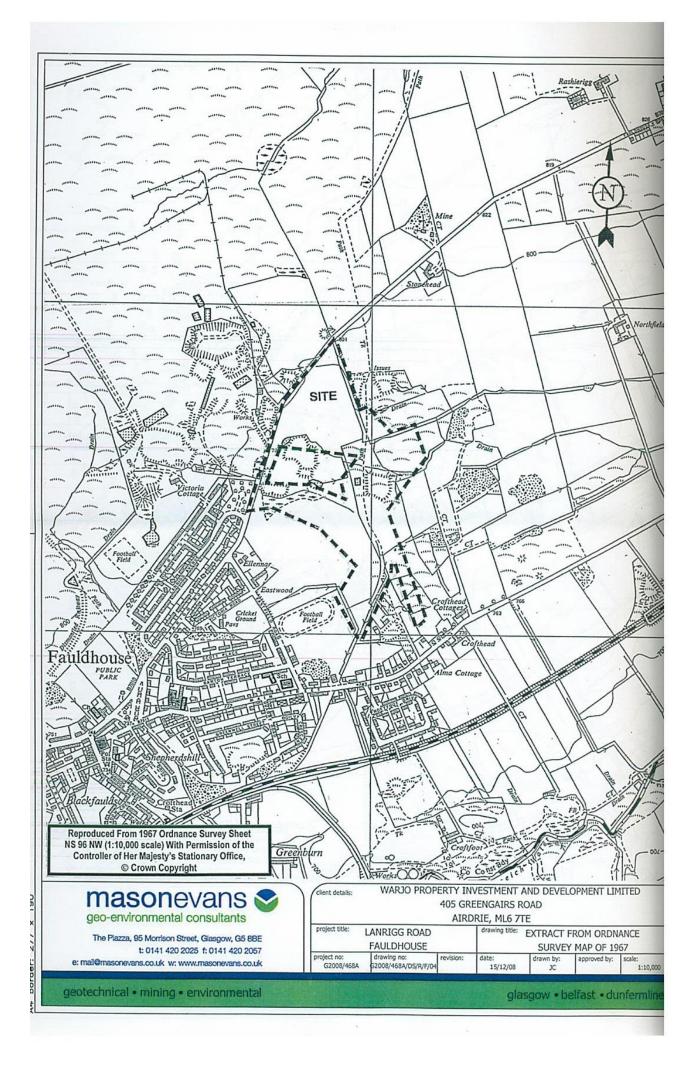
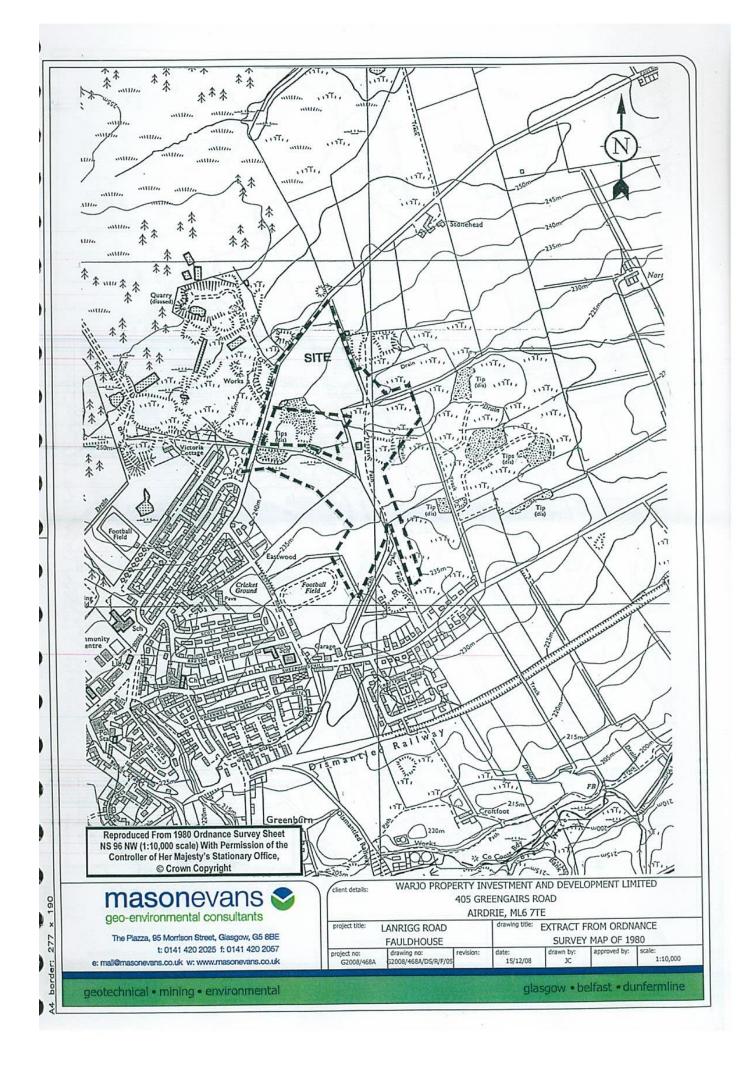
From the first available Ordnance Survey map dated 1958 *the site* was indicated to contain a disused mine, associated spoil heaps with a mineral rail line in the centre and north of the site with areas of rough pasture in the north and south. The spoil heaps and features associated with the mine were recorded up to the latest available map edition of 1980 which also noted disused tips in the eastern area of the site (Drawing Nos G2008/468A/DS/F/03-05).

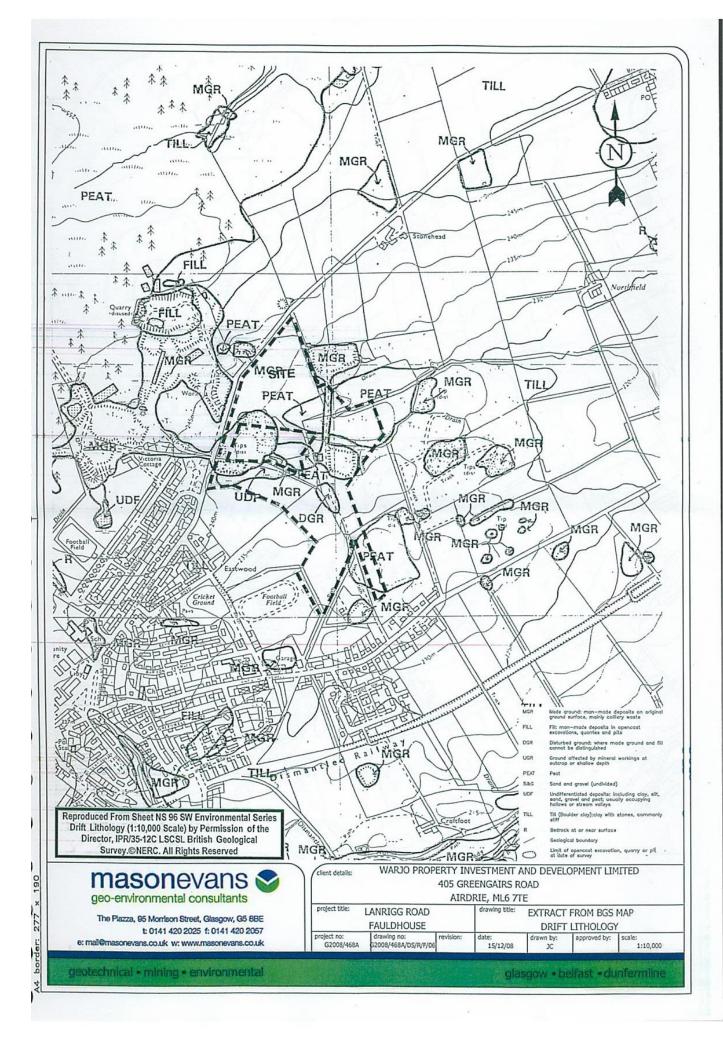
The available drift geology map indicates that the northern and southern site areas are underlain by Glacial Till with the central site area underlain by made ground, undifferentiated deposits (including clay, silt, sand, gravel and peat) and disturbed ground where made ground and fill cannot be distinguished (Drawing No G2008/468A/DS/F/06). The drift thickness is indicated to be approximately 5m (Drawing No G2008/468A/DS/F/07).

The desk-top researches indicate the potential for significant made ground soils underlain by particularly poor quality natural soils including peat. We would therefore recommend investigations to determine the nature and extent of the superficial materials throughout the site so definitive comment on foundation options can be made.

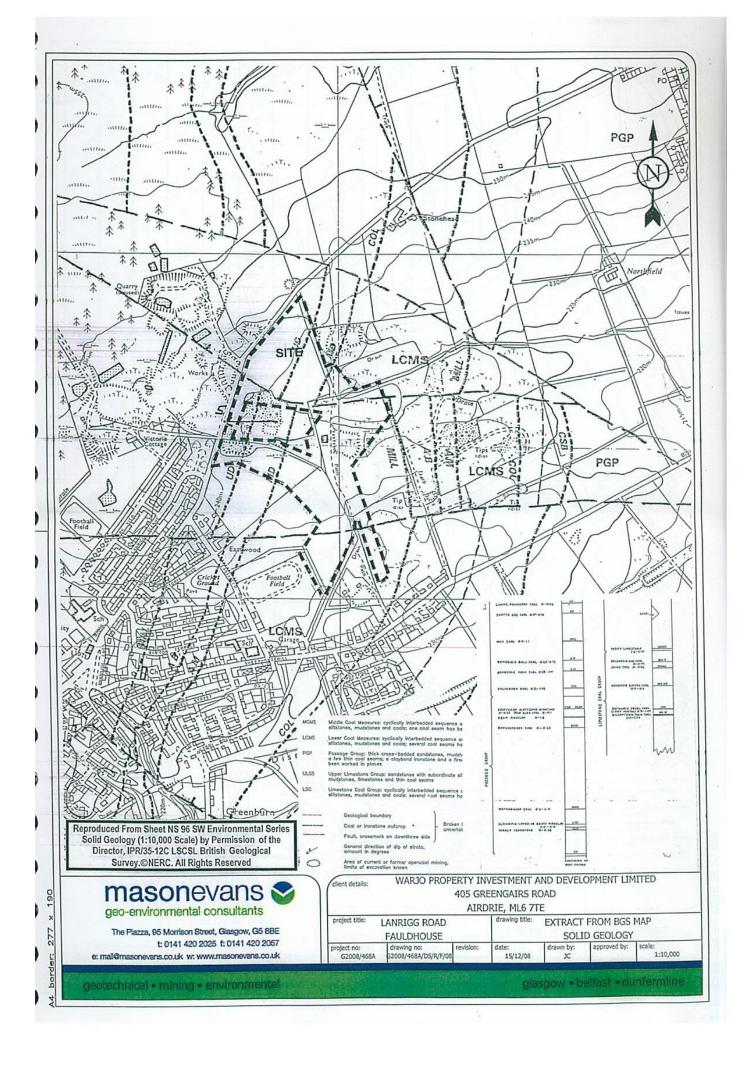
The bedrock geology underlying the site was recorded to consist of Carboniferous aged Lower Coal Measures mainly sandstone, siltstone and mudstone with seams of economic coal which have been worked and is indicated to be dipping at 5° to the west (Drawing No G2008/468A /DS/F/08).

The Upper Drumgray (Shotts Furnace) and the Mid Dumgray Coal are recorded to outcrop in the west and centre of the site. The Mill Coal and the Colinburn Coal outcrop directly to the east of the site, due to the westerly direction of dip these seams underlie the site at shallow depths. Two faults are noted within the site, in the north and south, downthrowing to the north, aligned generally east to west.

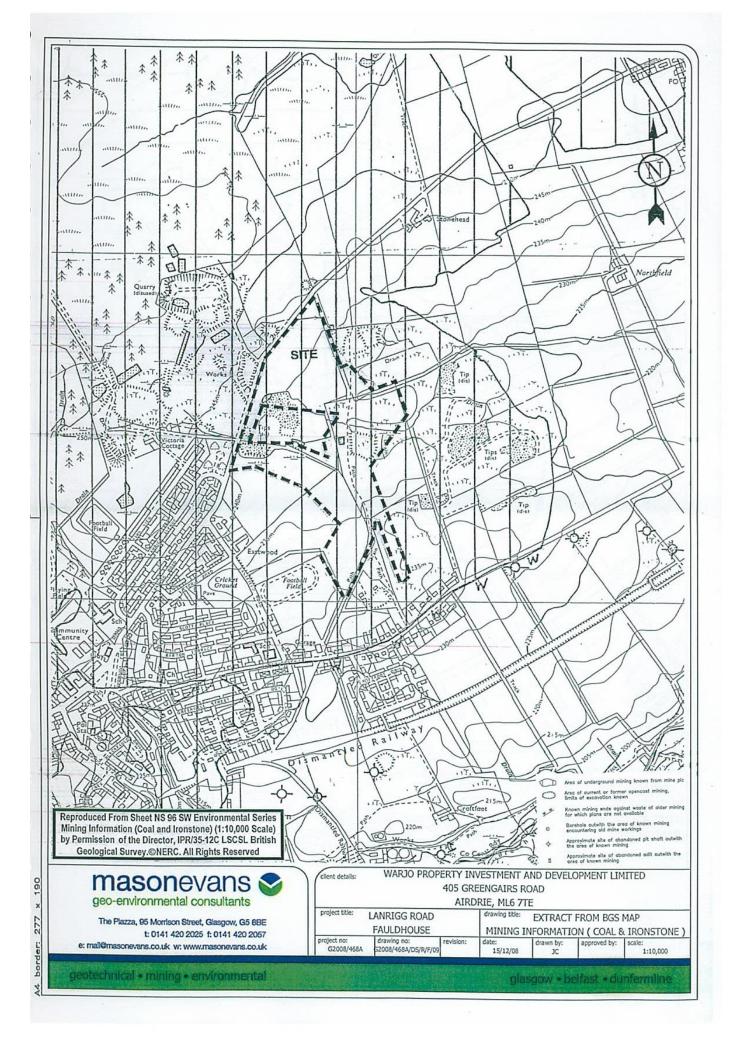
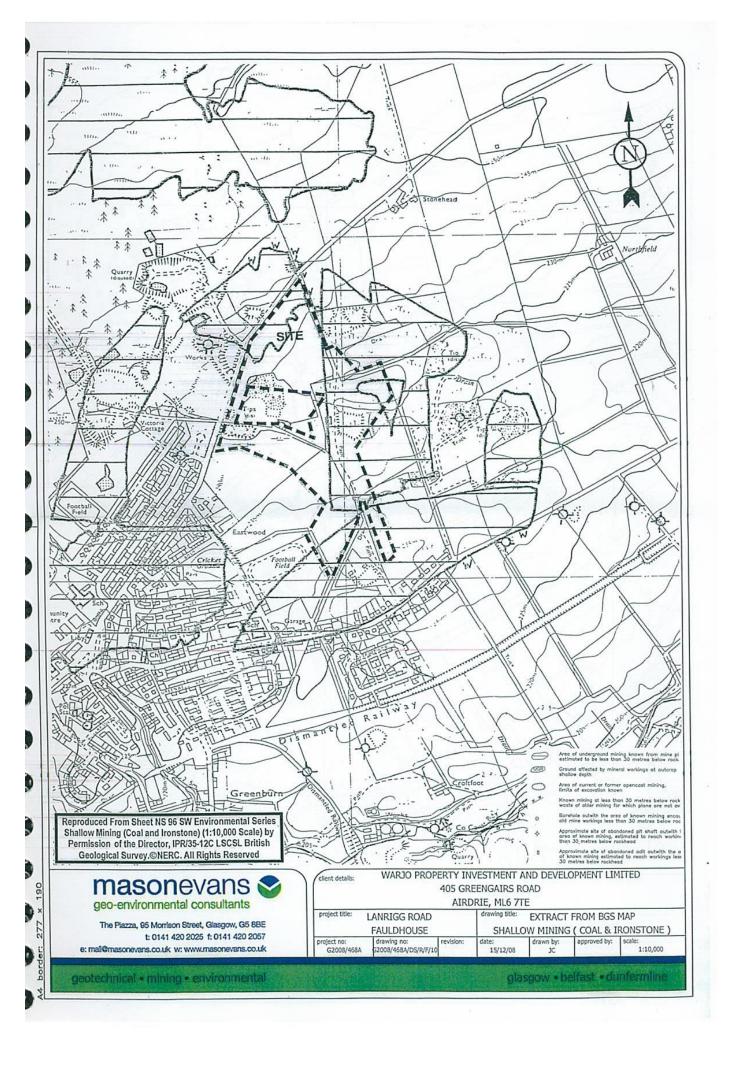
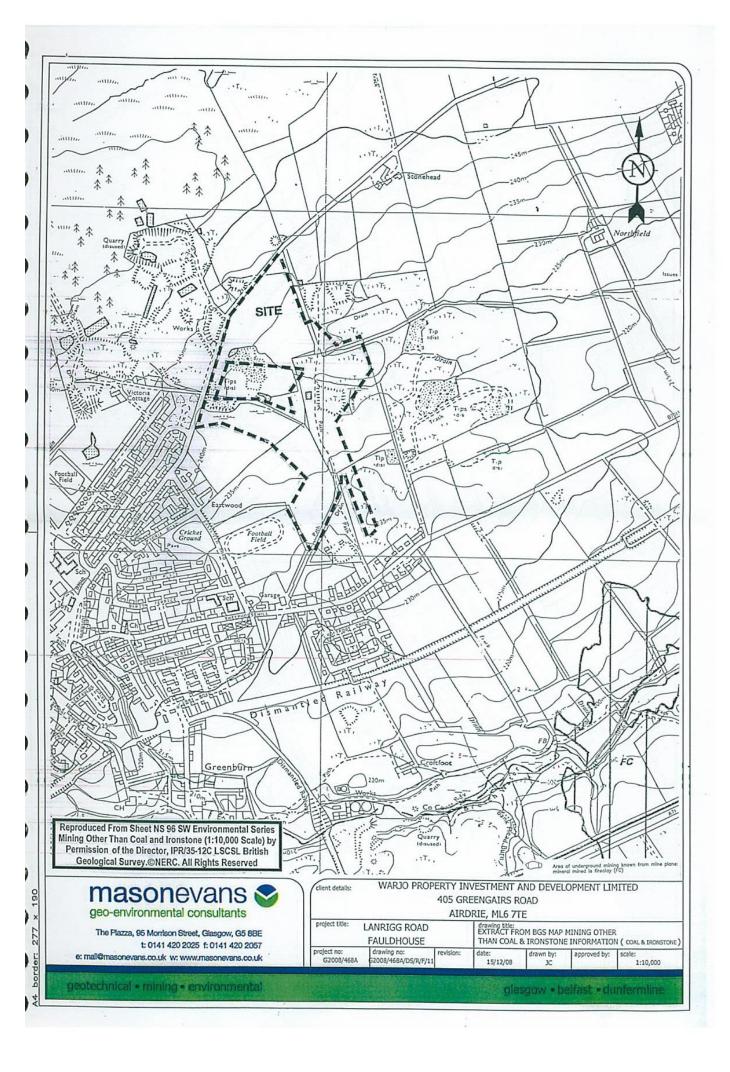
The site is underlain by strata of the Lower Coal Measures which contain historically economic coal seams. From available information, mining is indicated to underlie the entire site with areas in the north, east and south indicated to be at depths of less than 30m below ground level. Three pit shafts were recorded within the site boundaries, one in the east and two in the west (Drawing No G2008/468A/DS/F/09-11).

Our researches have recorded evidence of previously worked mineral seams at shallow depths beneath the site, which may adversely affect ground surface stability. Mineral investigations are therefore required to determine the presence (if any) of shallow mine workings within the site.

Three mineshafts were indicated to be present within the boundaries of the site. These will require to be located and appropriately treated. As in all areas of historic mining vigilance should be maintained (during future site works) for the presence of unrecorded mineshafts or infilled quarries.

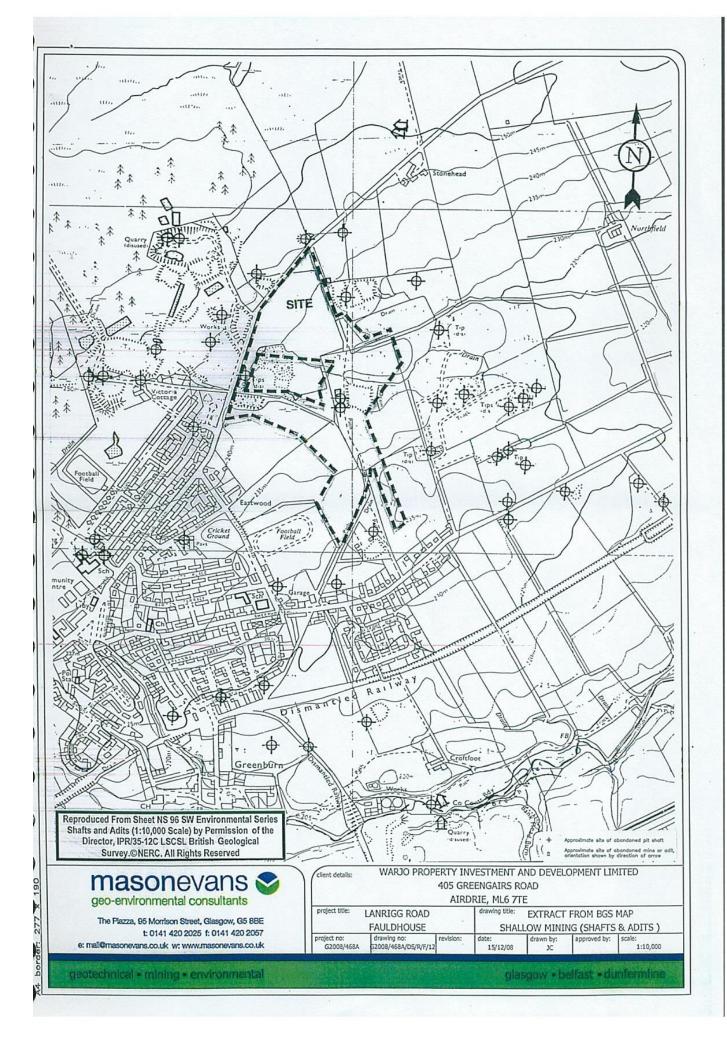
Numerous pit shafts and adits are also recorded in the immediate area surrounding the site (Drawing No G2008/468A/DS/F/12). However, in areas of historical mining the presence of further (unrecorded) mine entries cannot be discounted.
