Linlithgow Public Realm Design Guide

This public realm design guide has been prepared by Brindley Associates Ltd Landscape Architects with EK:JN Conservation Architects on behalf of West Lothian Council (WLC) for Linlithgow town centre, West Lothian. This design guide focuses on the section of Linlithgow High Street between West Port and Low Port, defined by WLC as the geographical extent of the study in June 2014 see plan overleaf. Consideration is also given to public open spaces lying to the north and south of High Street at the request of WLC to include Rosemount Park, Learmonth Gardens, Regent Square, Provost Road, The Peel, Palace Rose Garden and Lochside area in accordance with the Civic Trust's 'Vision' document.

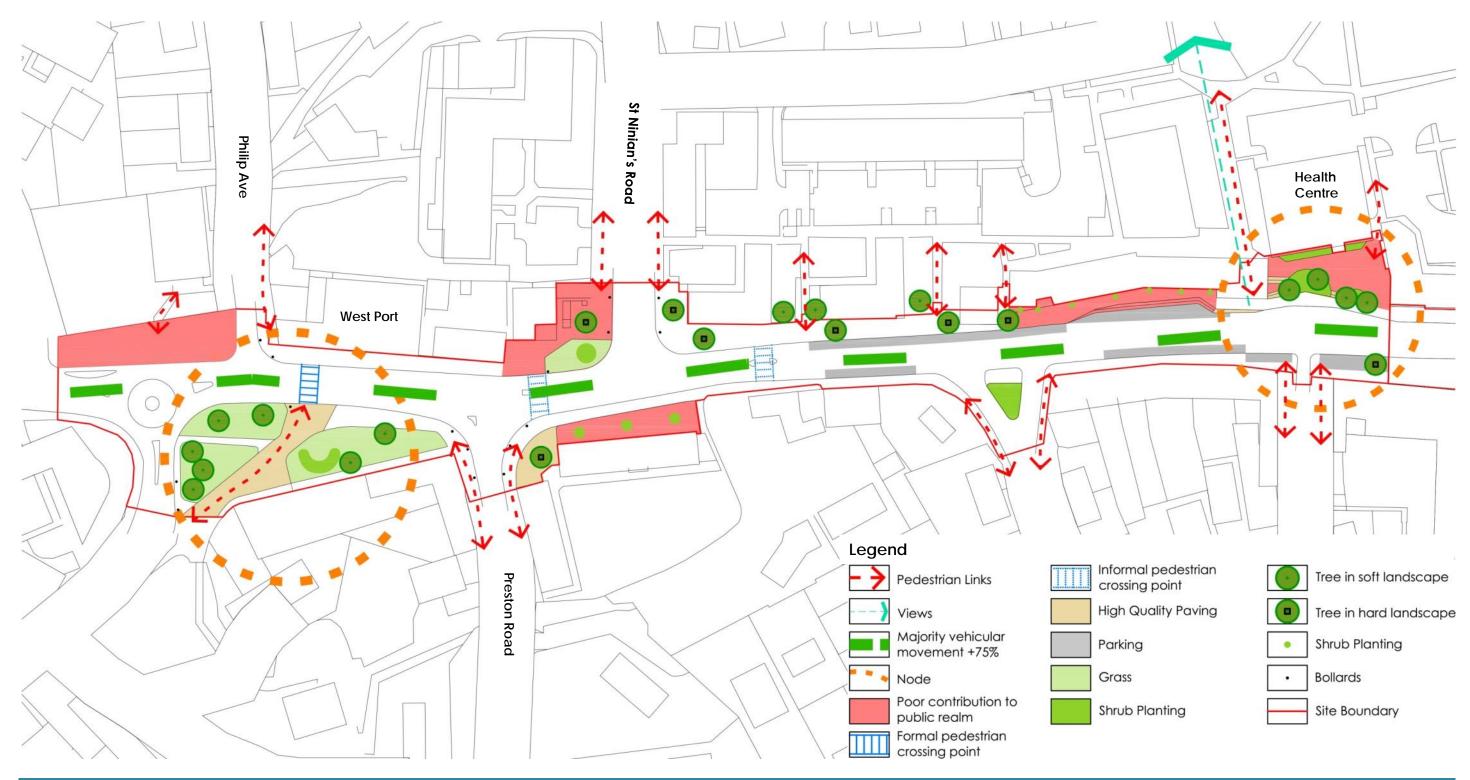
Inappropriate and damaged shrub planting within red gravel against modern flatted development falls short of Linlithgow's standard of attractive and wellmaintained public planting areas.

Large, cylindrical concrete bollards around West Port are a potential trip hazard and contrast with black cast-iron street furniture located elsewhere along the High Street.

Opportunity for seating to be arranged along southern edge of green space at the Katie Wearie Sundial. This would allow users to address the floral planting and create more of a separation between the recreational seating area and the road.

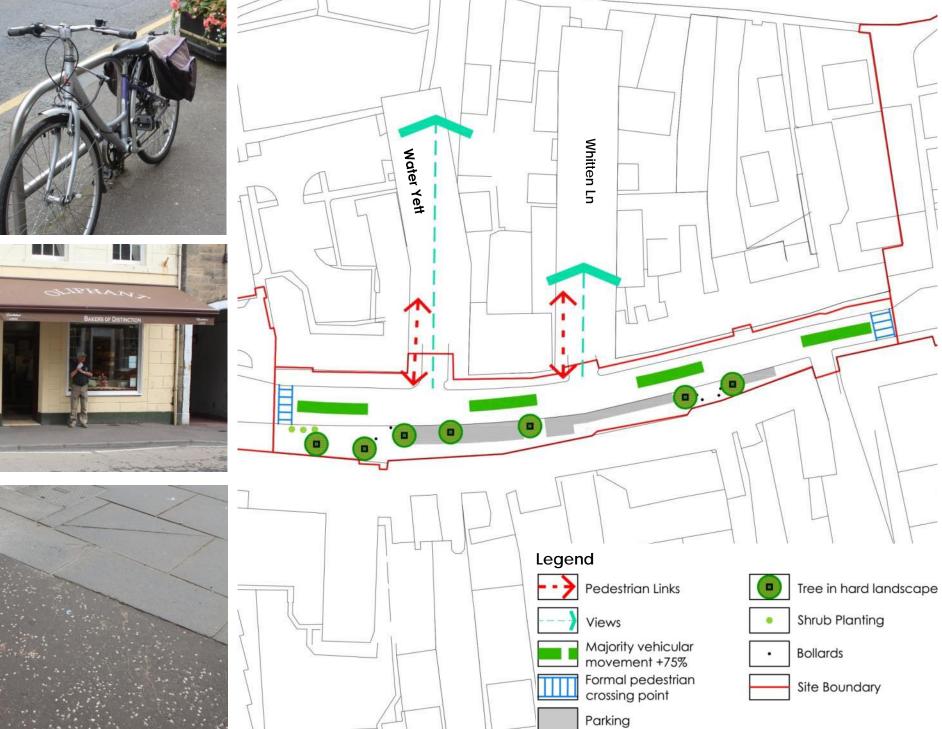
Right: Abrupt change in surface materials at transition into character area.

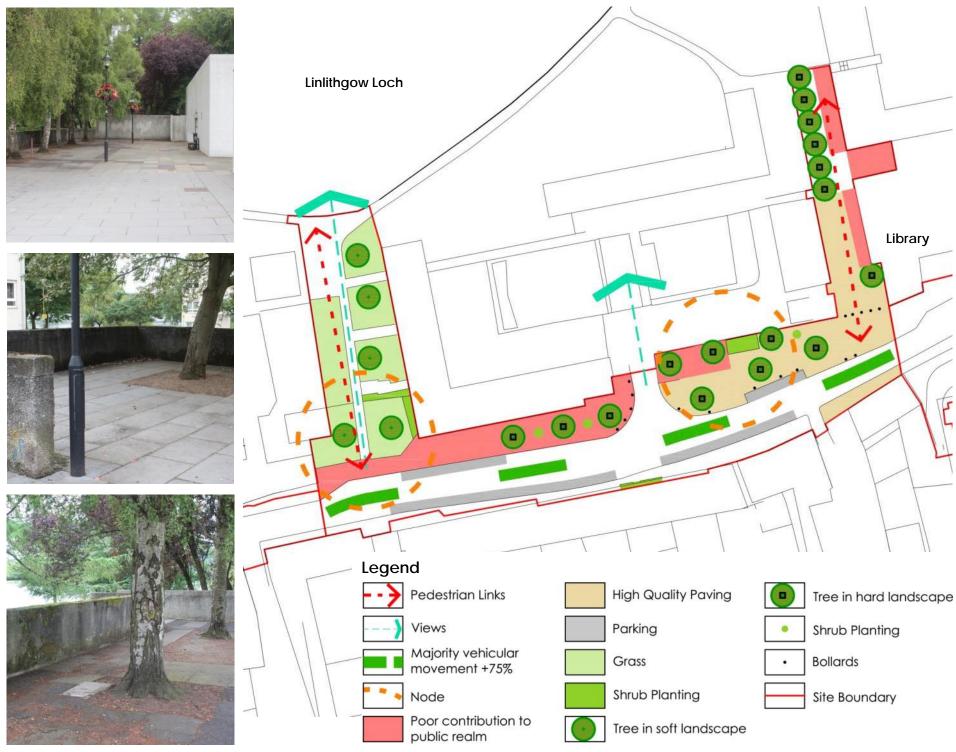
Right: Poor quality paving, walling and tree planting detracts from public realm and discourages use of space.

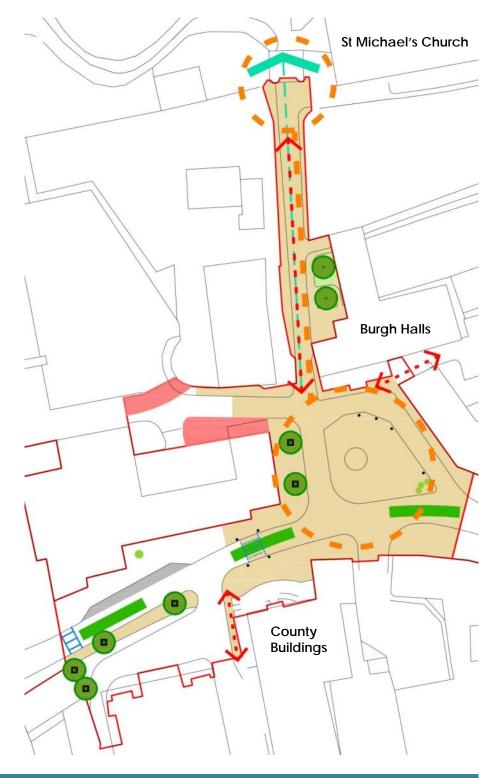
Left: Poor quality implementation and attention to detail detracts from quality of materials and leads to potential trip hazards

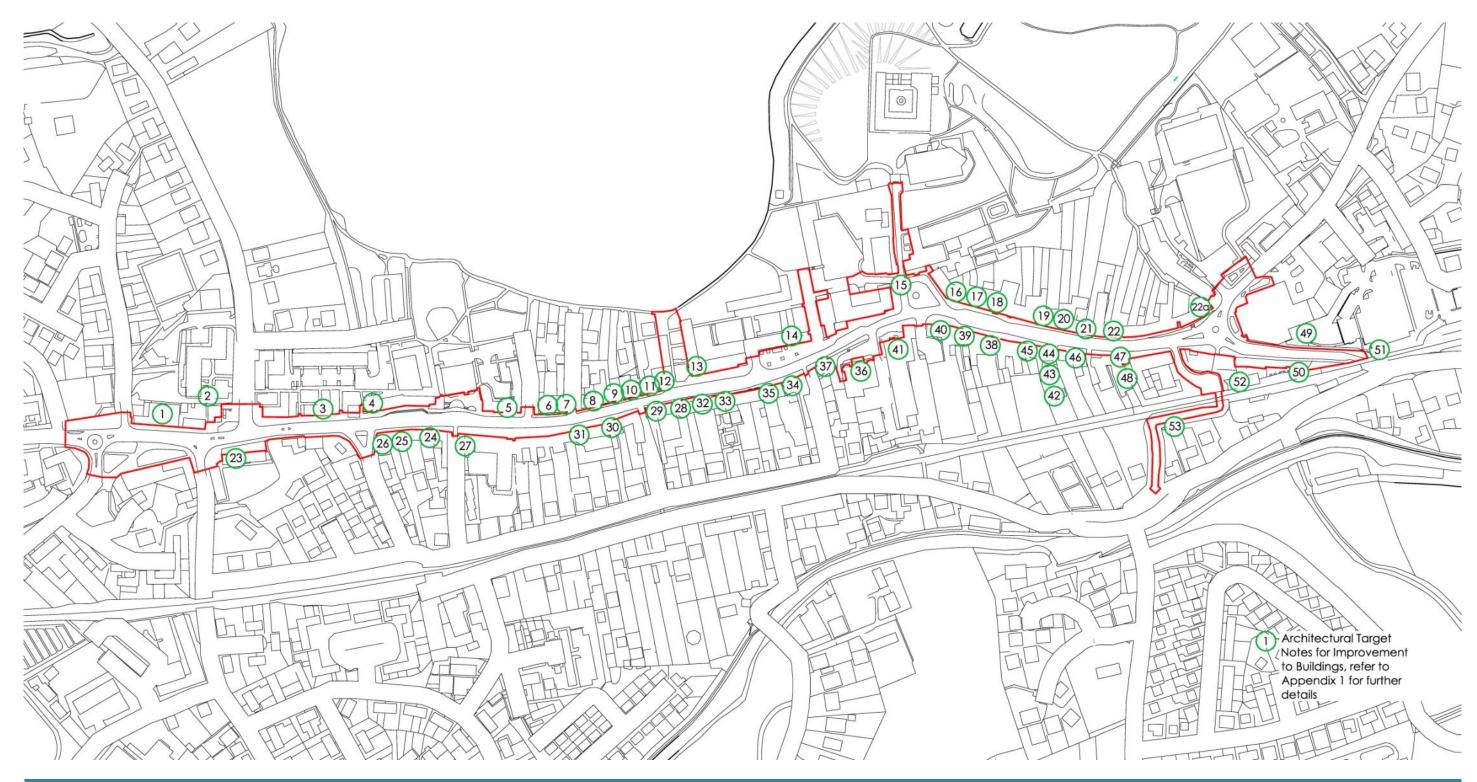
3.6 Architectural Recommendations Location Plan

1 3 318-348 High Street Some repairs to rainwater goods and harling would improve t 2 290-316 High Street Some repairs to rainwater goods and harling would improve t 5 264-284 High Street Proliferation of satellite dishes detracts. 6 258-260 High Street Dormers and rainwater goods in need of maintenance. 7 246-248 High Street Dormers and rainwater goods in need of maintenance. 8 238 High Street Missing chinney pots. Weeds growing at roof level. 9 230 High Street Lost chinney-stack to left I.h. and weeds growing in the roof I replaced with traditional 12-pane sash and case when oppo 10 226-228 High Street Lost chinney-stack to left I.h. and weeds growing in the roof I replaced with traditional 12-pane sash and case when oppo 11 224 High Street Façade includes brackets for flagpoles, unused. 12 212, 214 High Street Façade includes brackets for flagpoles, unused. 13 56-99 The Vennel Weeds growing on various ledges and roofs. 14 28 The Vennel Harling and parapet cappings in need of maintenance. UPVC 15 The fountain was repaired circa 2005, but is no longer function fountain would add significantly to the value of this area as a small but significant building in a key location in the town, in refurbished (2014).	1 12-14 Westport: The Black Bitch Inn	Some slipped slated requiring attention. Non-traditional windo 12-pane sash and case when opportunity presents. Some we

4 290-316 High Street Some repairs to rainwater goods and harling would improve to 5 264-284 High Street Dormers and rainwater goods in need of maintenance. 7 246-284 High Street Dormers and rainwater goods in need of maintenance. Front bracket for a hanging sign. 8 238 High Street Missing chimney pols. Weeds growing at roof level. 9 230 High Street First floor windows, right and centre are new in heritage colou 10 226-228 High Street Lost chimney-stack to left I.h. and weeds growing in the roof f 12 241, 214 High Street Foot windows in need of maintenance. Replacement of the character of the building's heritage could be considered. 12 212, 214 High Street Façade includes brackets for flagpoles, unused. 13 56-99 The Vennel Weeds growing on various ledges and roofs. 14 28 The Vennel Harling and parapet cappings in need of maintenance. UPVC 15 The Cross The fountain was repaired circa 2005, but is no longer function fountain would ad significantly to the value of this area as a som th. 16 114 High Street Dormer in need of general maintenance. Painted façade in refurbished (2014). 17 106,108 High Street: Dancewear UPVC sliding sash windows should be replaced with traditional 12-pane sash and case on 1		Improvements to reduce the visual impact of the ugly steel ch

5 264-284 High Street Proliferation of satellite dishes detracts. 6 258-260 High Street Dormers and rainwater goods in need of maintenance. 7 246-248 High Street Dormers and rainwater goods in need of maintenance. Front bracket for a hanging sign. 8 238 High Street Missing chimney pols. Weeds growing at roof level. 9 230 High Street First floor windows, right and centre are new in heritage color 10 226-228 High Street Lost chimney-stack to left I.h., and weeds growing in the roof f 11 224 High Street Lost chimney-stack to left I.h., and weeds growing in the roof f 12 212, 214 High Street Front windows in need of maintenance. Replacement of the character of the building's heritage could be considered. 12 212, 214 High Street Façade includes brackets for flagpoles, unused. 13 56-99 The Vennel Weeds growing on various ledges and roofs. 14 28 The Vennel Harling and parapet cappings in need of maintenance. UPVd 15 The Cross The fountain was repaired circa 2005, but is no longer function fountain would add significantly to the value of this area as a 16 114 High Street Small but significant building in a key location in the town, in refurbished (2014). 17	3 318-348 High Street	Some repairs to rainwater goods and harling would improve t

6 258-260 High Street Dormers and rainwater goods in need of maintenance. 7 246-248 High Street Dormers and rainwater goods in need of maintenance. Front bracket for a hanging sign. 8 238 High Street Missing chimney pots. Weeds growing at roof level. 9 230 High Street First floor windows, right and centre are new in heritage colou 10 226-228 High Street Lost chimney-stack to left Lh, and weeds growing in the roof f replaced with traditional 12-pane sash and case when oppoint 11 224.214 High Street: The Baird Hall Front windows in need of maintenance. Replacement of the character of the building's heritage could be considered. 12 212, 214 High Street Façade includes brackets for flagpoles, unused. 13 56-99 The Vennel Weeds growing on various ledges and roofs. 14 28 The Vennel Harling and parapet cappings in need of maintenance. UPVG fountain would add significantly to the value of this area as a Small but significant building in a key location in the town, in refurbished (2014). 17 106,108 High Street: Dancewear Dormer in need of general maintenance. Painted façade in r windows could be replaced with traditional 12-pane sash and case of the sing as the windows should be replaced with traditional 12-pane sash and case of the sing chimney cans. 18 102,104 High Street Dormer in need of general maintenance. Painte	4 290-316 High Street	Some repairs to rainwater goods and harling would improve t

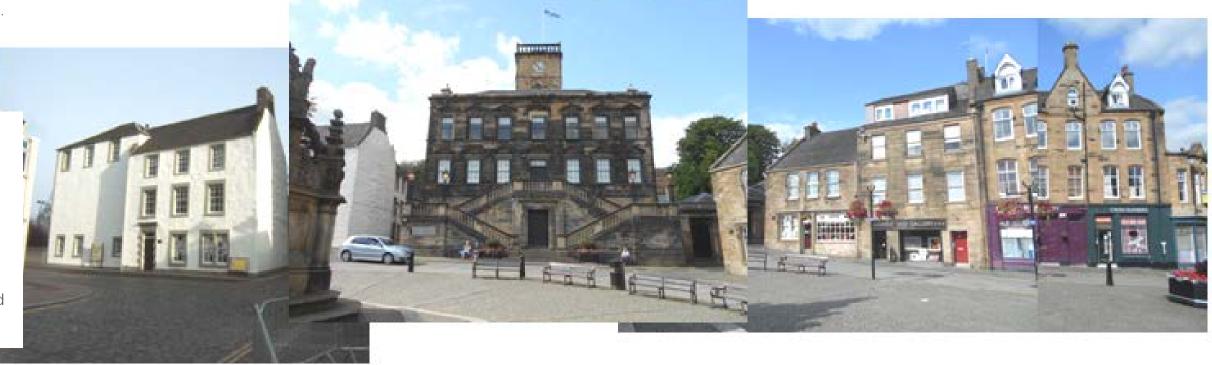
Missing chimney cans.

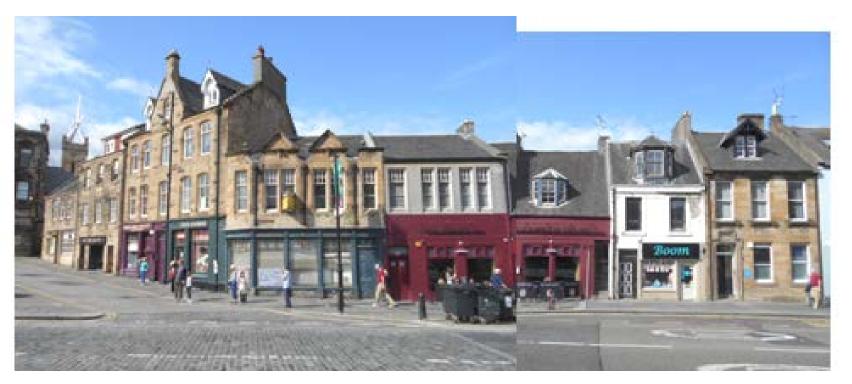
Leaking rainwater pipe.

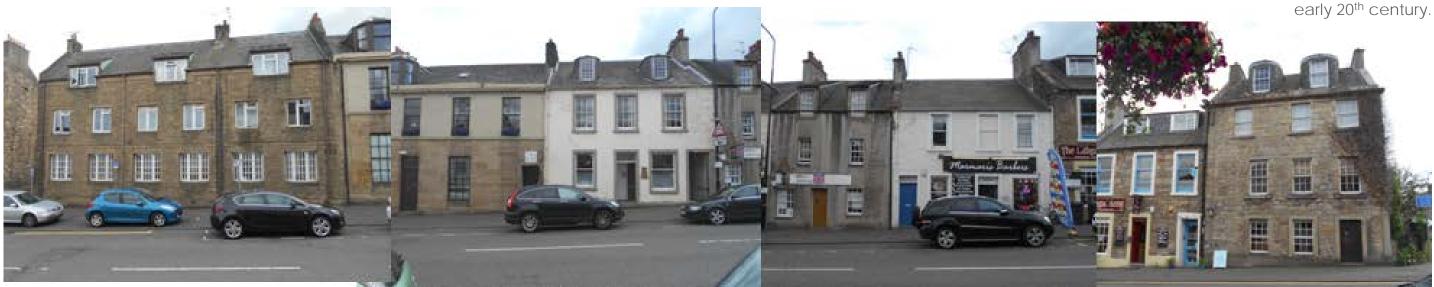
247-255 High Street: 20th century. Sandstone with slate roof. Catslide dormers. UPVC windows are regrettably not sympathetic with the surrounding buildings.

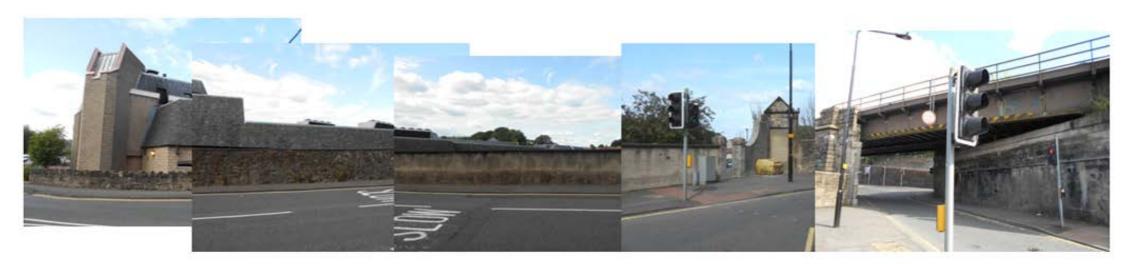
From Lowport to Highport. This area has suffered from lack of attention for many years.

Rear wall of the service yard for Tesco is in need of routine maintenance. The railway bridge heading out towards Edinburgh Road could be much improved, and the historic gateway which once led into the Nobel factory is in need of maintenance. Weeds growing in the Nobel gateway and on the stonework of the railway bridge.

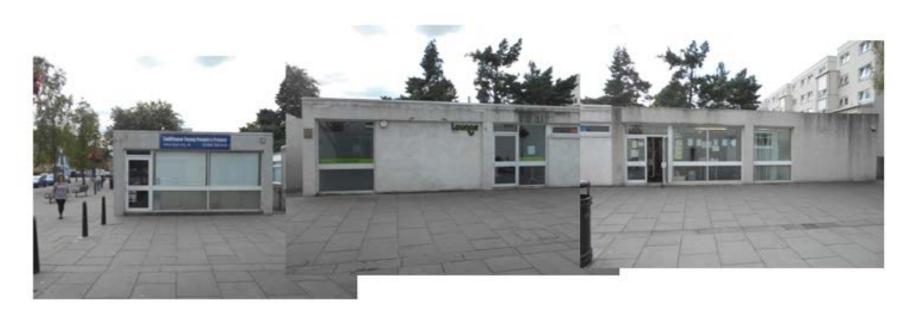
28-30 The Vennel. 1960s flat-roofed development, out of character with much of the surroundings.
