# Torphichen

Consultative Draft Conservation Area Appraisal

West Lothian Council - Planning Services

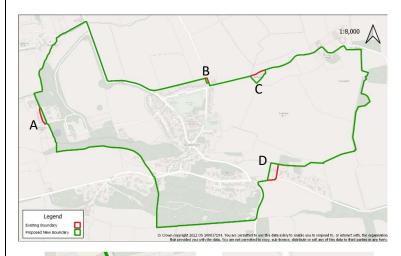
Some of the areas in the conservation area, add no significant historical, cultural or architectural significance to the area. 4 insignificant areas have been identified.

- A. Agricultural shed.
- B. Roadside sheds for nearby residential properties.
- C. Unlisted residential building.
- D. 2 Unlisted residential buildings.

The conservation area boundary should be adjusted to exclude these 4 areas from the Torphichen Conservation Area.

- A. The conservation area boundary should be adjusted to run along the western property line to exclude the agricultural sheds.
- B. The conservation area boundary should be adjusted to run along the rear side of the sheds/ along the western property line of the adjacent residential property excluding the sheds.
- C. The conservation area boundary should be adjusted to run around the residential lot along the East, South and West property line excluding this lot.
- D. The conservation area boundary should be adjusted to run around the two residential lots, along the west and north property lines excluding the two lots.
