Produced by
West Lothian District Council
Planning Department

The Farmsteadings of the Bathgate Hills

**THE
FARM STEADINGS
OF THE
BATHGATE HILLS**

**Nils White
WEST LOTHIAN DISTRICT COUNCIL
PLANNING DEPARTMENT
1991**

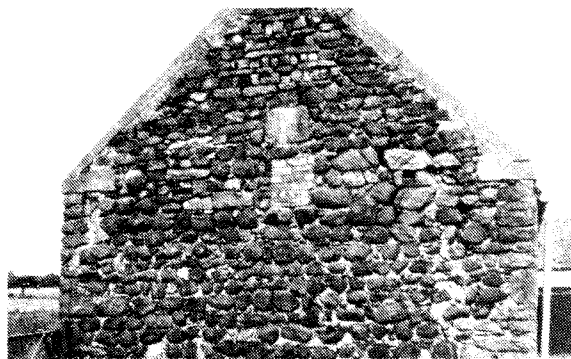
3. Quarter Farm: wall of weathered stone rubble

In pre-Improvement times, rubble usually consisted of loose, weathered stones cleared from the fields. These are easily recognisable by their rounded shape (3). After Improvement, it was more usual to extract building stone from quarries, although common sense demanded that old stone was re-used where the building replaced an earlier structure. In cases where extra height was needed, rather than rebuilding completely, an extra lift of stonework would be added to a wall (4), often illustrating a change of favoured building material.

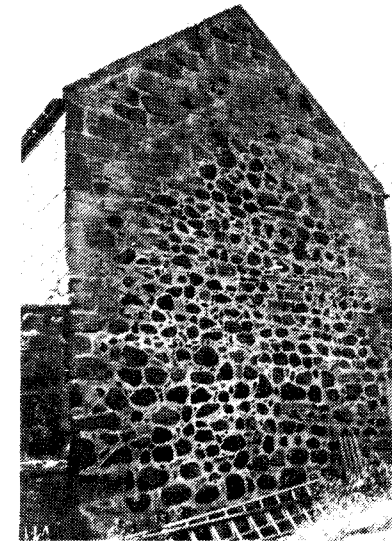
4. Hiltly: change of building material in upper courses.

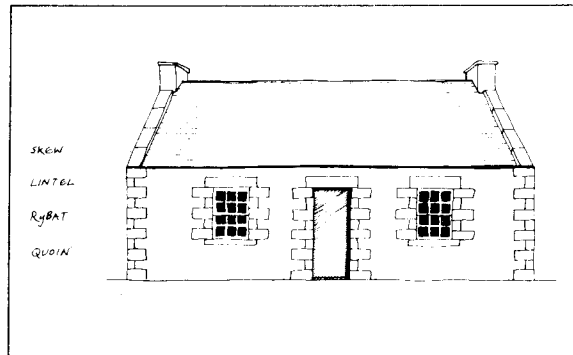
Figure 1: Dressed stonework.

There were parts of the building where straight edges were needed and for which crude rubble was inadequate: chimneys, skewes, quoins, rybats and lintels (fig 1). These are nearly always finished in dressed sandstone, regardless of the construction of the rest of the building.

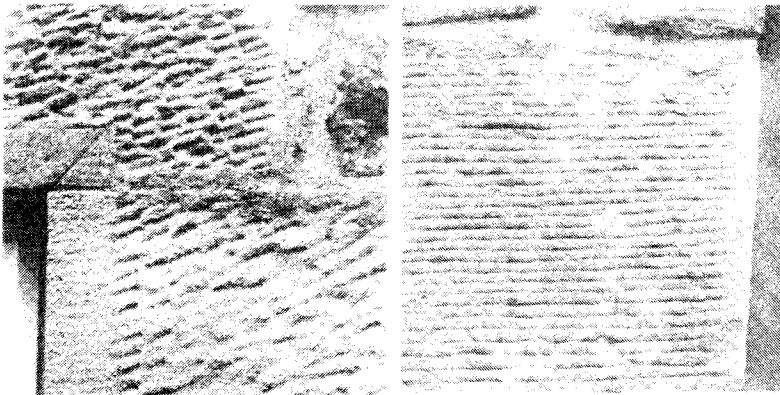
5. Stugging.

6. Droved sandstone.

This stone was either roughly tooled, a technique known as "stugging" (5), or given finer, smooth and "droved" finishes (6). Droving is often a sign of an eighteenth or early nineteenth century building, while stugging became more popular in the latter half of the nineteenth century. Both these techniques are illustrated in the boal hole of the barn at South Mains (7) dated 1848.

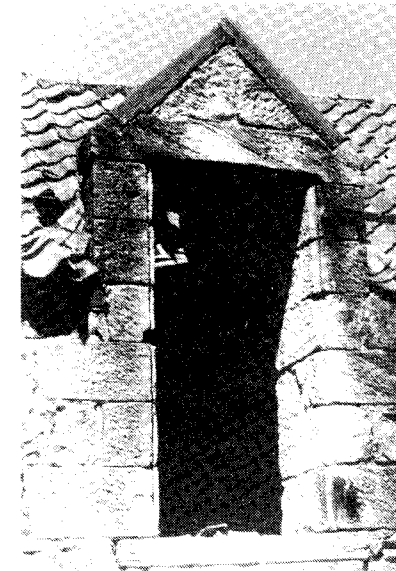
7. South Mains: upper storey boal hole in barn.

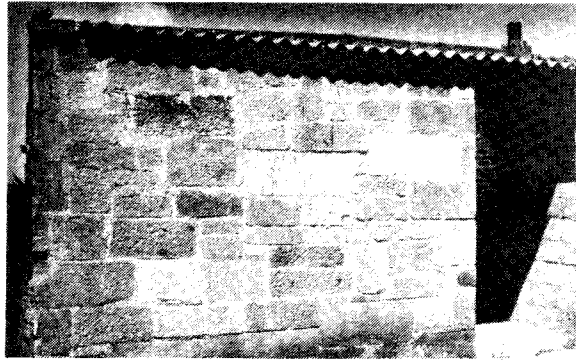
Ashlar stonework was not found on any of the agricultural buildings in the area, but there are examples of coarse, squared rubble (8). Nearly always this would be sandstone, but there are some cases where builders have gone to the trouble of dressing whin to a similar quality, providing a handsome contrast to dressed sandstone (9). Harled or whitewashed walls are unusual in the Bathgate Hills area.

8. Cathlawhill: stable wall constructed of squared sandstone rubble.

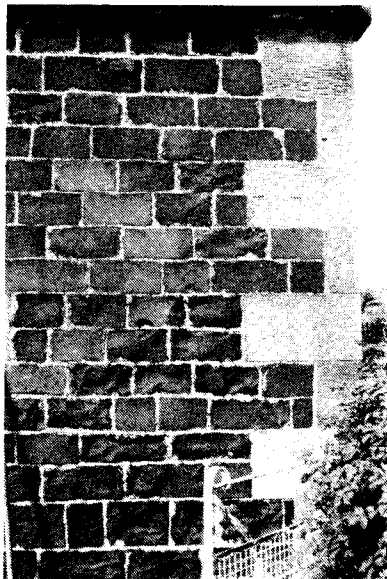
9. Ochiltree Mill: squared whinstone rubble with sandstone dressings.

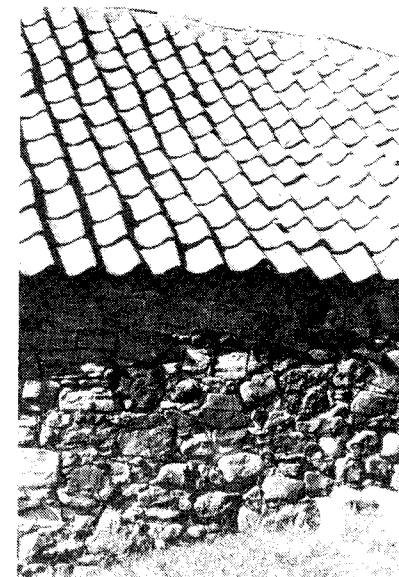
10. South Mains: pantile roof.

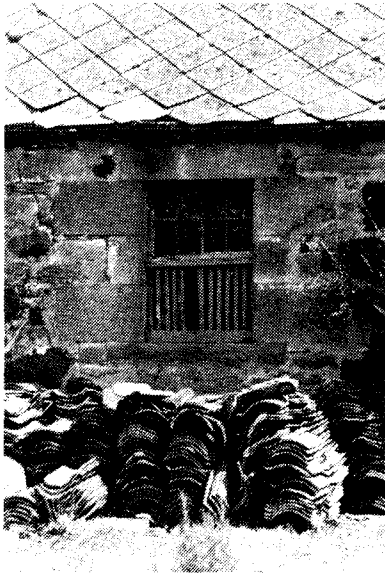
11. Drumcrosshall: asbestos slates laid in a diagonal pattern. At the base of the wall are stacked pantiles salvaged from the cattle court, now demolished.

At Drumcrosshall, asbestos slates, laid in an attractive diagonal pattern, are used (11).

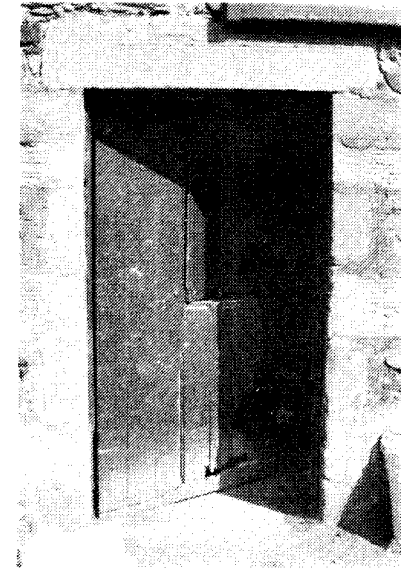
12. Bankhead : double leaf door.

Usually, the original joinery survives intact and the quality and ingenuity of the work involved is often impressive: doors were often designed to allow varying amounts of draught into the building (12), and were sometimes split both vertically and horizontally permitting almost infinite adjustment.

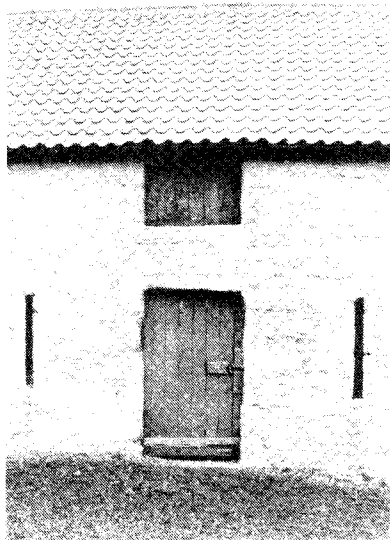
13. Easter Carribber: 18th century barn with arrowslit vents.

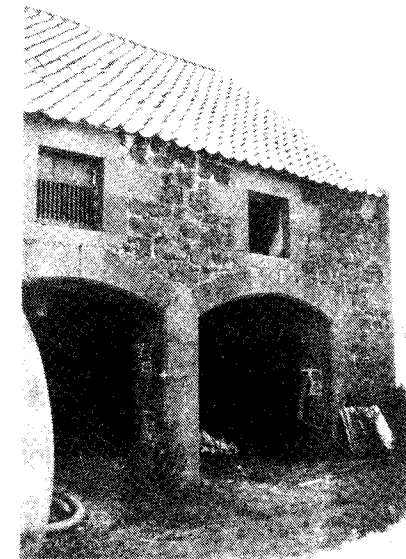
The grain that was produced by the thrashing operation was put into sacks and stored in an upstairs granary. Very often the granary was in the same building as the barn and commonly there would be a cart shed underneath. The exterior of cart and implement sheds on farm steadings can be very fine with a series of arches over the individual ports (14). Usually they are built of stone but, in the late 19th century, cast iron piers were sometimes used.

14. North Mains: twin port cart shed with granary above.

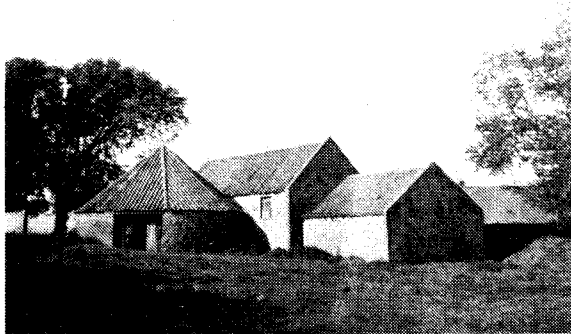
15. West Broadlaw: horse mill c.1963. The roof has since collapsed.

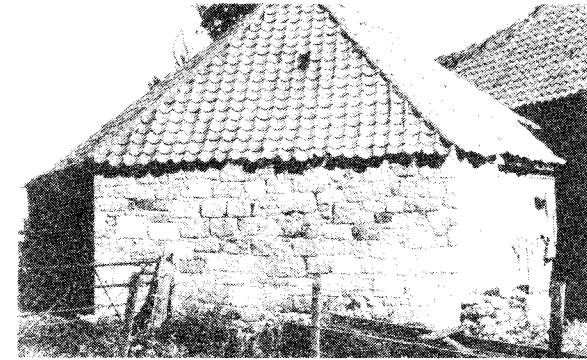
16. Cauldhame: horse mill.

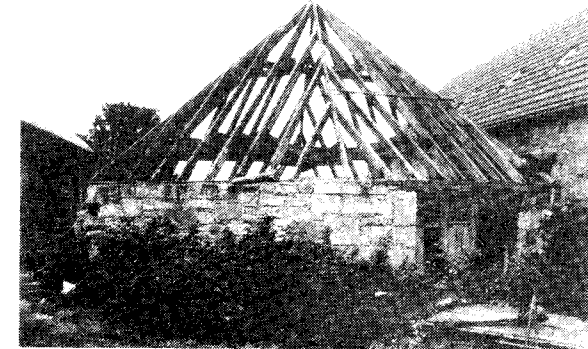
17. The Byres: horse mill with pantiles removed.

Despite their principally functional nature, where they do survive, the quality both of stonework and the intricate joinery employed in the roof is often impressive. Indeed, their aesthetic qualities may well have been appreciated by those who built and used them. This is suggested by the use of black glazed pantiles on the horse mills at Wester Druncross and at Williamcraigs, which contrast with whitewashed walls in the case of the latter. Although the removal of tiles from the roof of the horsemill at The Byres farm (17,41) represents a loss, hastening the decay of the building, it does serve to reveal the elaborate joinery used.

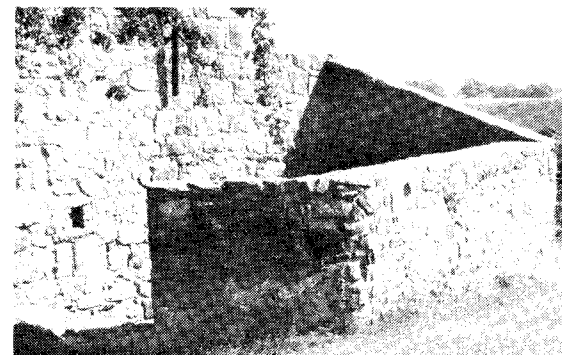
In the Bathgate Hills, there are no remains of windmills, but water was a common source of power in the valleys where it was readily available. Several examples of wheel houses (18), remains of machinery, lades and millponds exist; at Wallhouse the wheel house and pit for an undershot wheel (meaning that the water flow that provided the motive power passed under the wheel) are still in place and the flagstones which lined the long, sunken lade are still sometimes uncovered when the field it passed through is ploughed.

18. East Broadlaw; wheelhouse dated 1864.

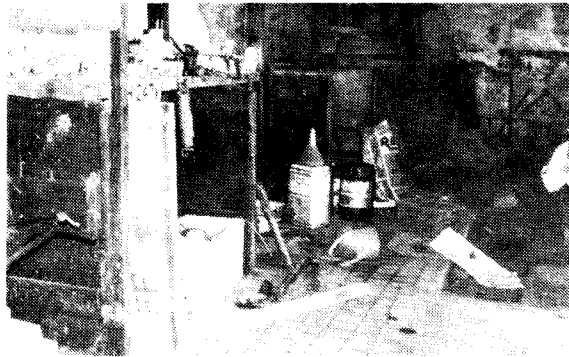
19. Hiltly: byre with wooden trevices.

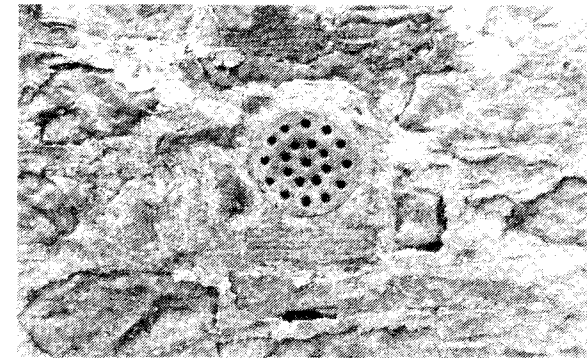
Ventilation was another necessary requirement for the cows and there were several different designs for the individual wall vents found in many byres. (20)

20. South Mains: ceramic vent in wall of the byre.

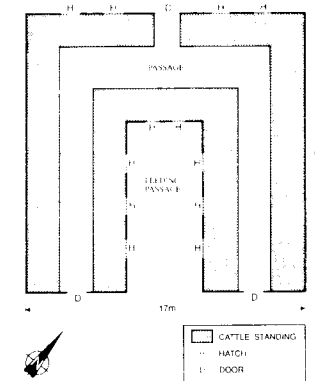
Fig.2 West Bangour Farm:
plan of cattle court.

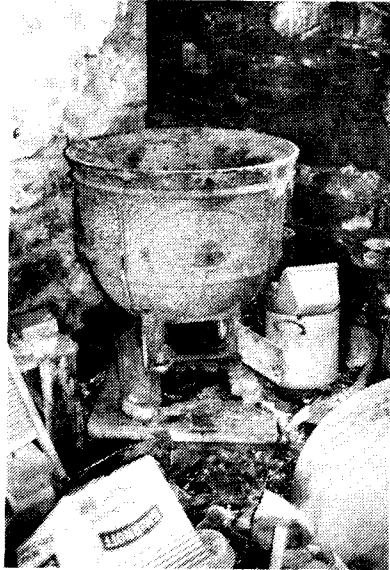
22. Quarter Farm: boiler.

The cattle fodder varied between farms, depending in part on what was grown. Turnips were commonly used on some farms. Sometimes these were boiled up in a large cast iron urn in purpose-built boiling houses, such as the one at Quarter Farm (22). On other farms, a mash was specially prepared. At Cauldhame, one mile from Linlithgow, the mash typically consisted of draff mixed with beanmeal, peasmeal, and treacle. Draff (used brewer's grains) was a by-product of the nearby distillery.

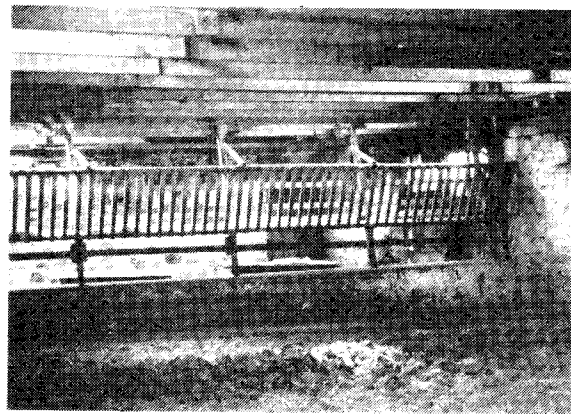
Later, commercially made cattle cake was bought in, usually coming in blocks which had to be broken up before being fed to the animals. Hay was fed to the cattle from overhead hecks (23).

23. North Couston Farm: heck.

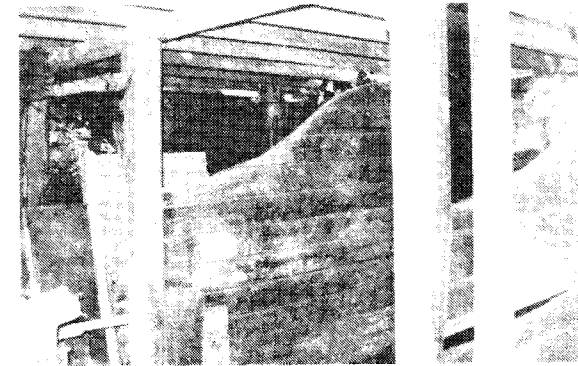
Horses were the principal power source on the farm before the mechanisation of agriculture, and it was therefore imperative that they should be looked after well. By the middle of the last century, most stables had stalls for individual horses. The trevises were usually swept up at the wall end to prevent the animals from biting each other (24).

24. Wairdlaw: wooden trevises in stable.

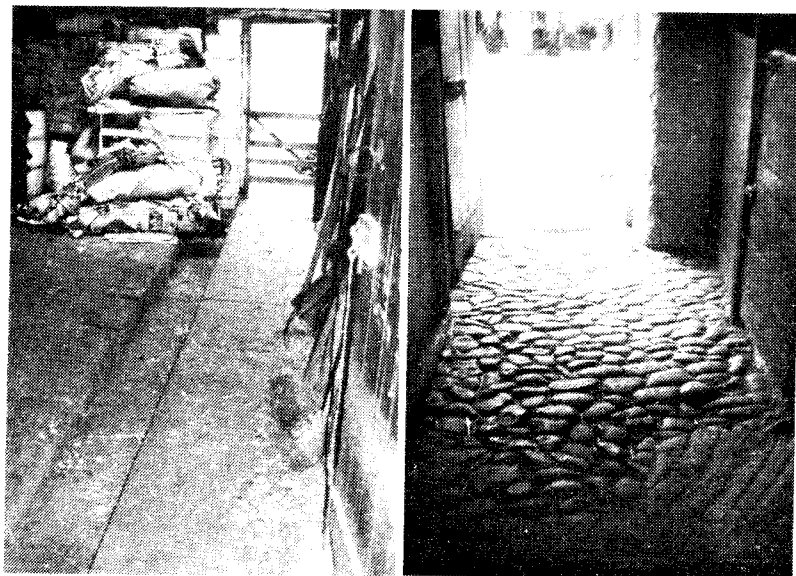
The floor of the stalls was cobbled, providing a dry, hard wearing surface. The rest of the floor was often covered in flagstones and might include a 'gruip' (25), which was the gutter running down the centre. There are still good examples of cobbled stable floors at Wester Gormyre (26) and Brunton.

25. Wester Gormyre: griip

26. Wester Gormyre: cobbled floor of stable.

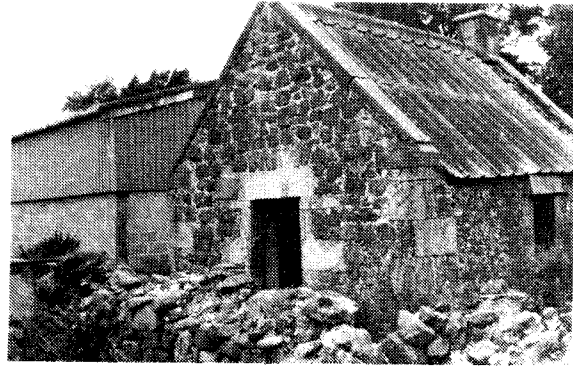
There is quite wide variation between bothies in the area. The small building at Craigmaling (28) was variously used as a dairy and bothy. The west-facing window was no more than a slit, which would have been stuffed with rags to exclude draughts. Although a bothy such as this one scored low on creature comforts, the building was hardly ramshackle, with its careful detailing and handsome proportions. Bigger farms would have larger, more comfortable bothies.

28. Craigmailing: bothy

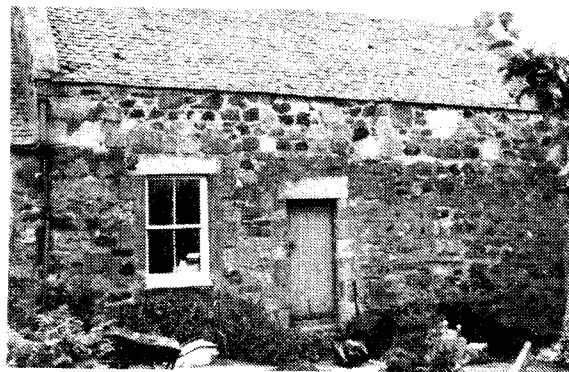
The bothy at Wairdlaw (29) could have been quite comfortable, with its range and even a sash and case window. This contrasted with the rather ascetic conditions imposed on the workers at Craigmailing(28), only a quarter of a mile away.

29. Wairdlaw: bothy.

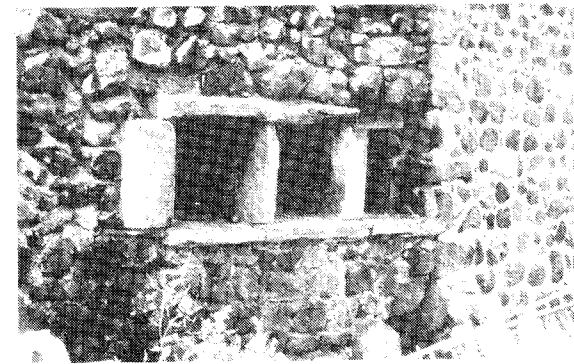
At Hiltly, there are some square, sandstone recesses in a wall (32). These are beeholes where the beehives were placed. They may have been secured in position by an iron bar which was padlocked into place, protecting the precious honey.

32. Hiltly: beeholes.

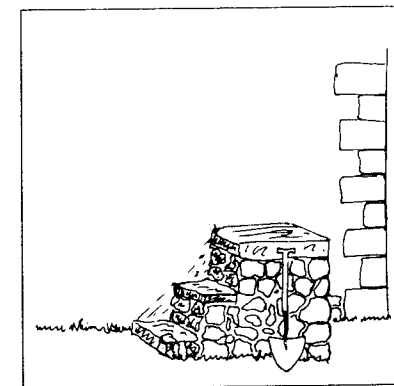
Also at Hiltly, there is a loupin-on stane, or mounting block (fig 3), to help riders into the saddle.

Figure 4, Hiltly: Loupin-on stane.

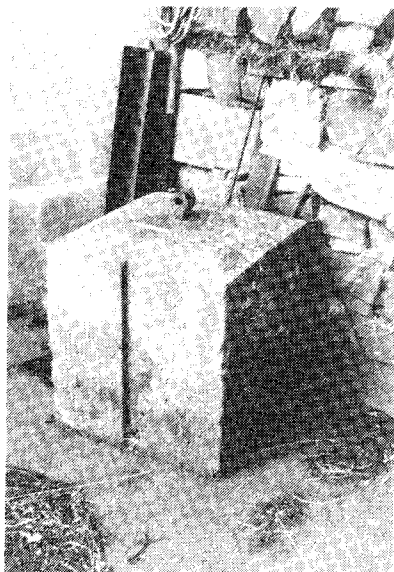
Often, lying outside the buildings, is the weight from a cheese press. This is a large lump of sandstone with grooves down the sides and an iron eye at the top. It shows how common cheese making once was on farms. Cheese presses were found at Bowdenhill, Wester Drumcross, Wester Gormyre, and at Ochiltree Mill, where the exceptionally well preserved weight illustrated stands in a corner of the farmyard. (33).

33. Ochiltree Mill: cheese press.

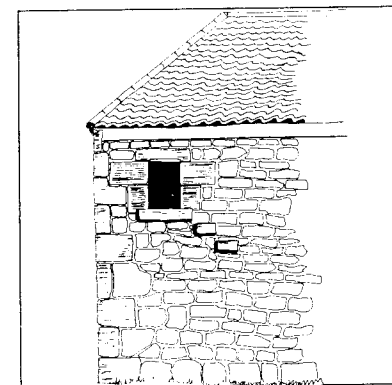
It was normal to keep hens on the farm and occasionally, as shown here at Hillhouse (fig 4), there is a purpose-built henhouse with steps for the birds to gain entry to the high level door.

Figure 5. Hillhouse: henhouse steps.

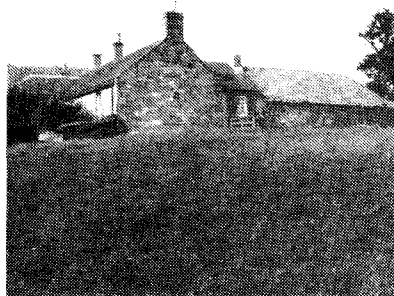
34. Cauldhame Farm: east elevation and figure 6 plan.

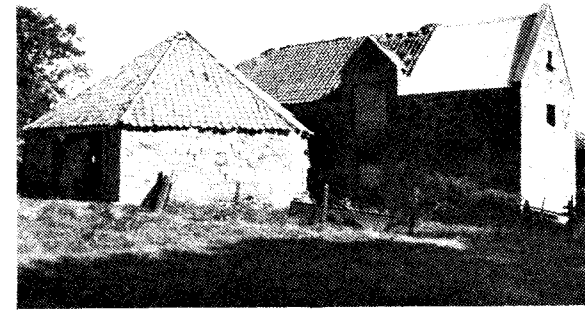
The most impressive building of the group is the combined barn and granary (35). It is constructed of squared rubble with a stugged finish, droved rybats and skews, and a pantile roof. The granary is at the south west end and has a single bay cart shed below it. Access was through the sheaf loft and there is an owl hole in the gable. The barn has an earth floor and originally had a sheaf loft with a hopper feeding the thrashing mill below, which was powered by a horse mill. There are two doors above each other, one at ground floor level, the other, known locally as the 'boal hole', leading to the sheaf loft. These were essential lines of communication between the operators of the thrashing machinery and the boy driving the horses, when the machinery needed to be slowed down or stopped.

35. Cauldhame: barn and horse mill showing barn door and boal hole.

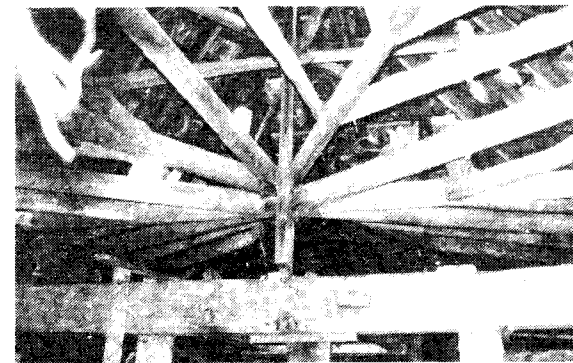
The horse mill, hexagonal on the outside, is circular within. The type of construction is similar to that of the barn. The last use of the building was for keeping pigs, for which makeshift sties were erected. Inside, the roof is constructed radially (36). Below this there is a stout cross beam, still with the bearing which supported the vertical axle.

36. Cauldhame: interior detail of horse mill roof.

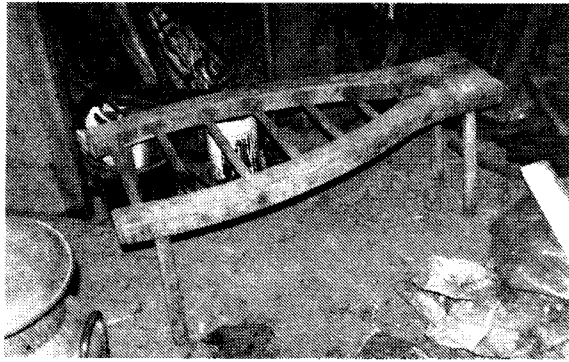
37. Cauldhame: clipping stool. The sheep was placed on its back on the bars while the shearer sat astride the stool on the right.

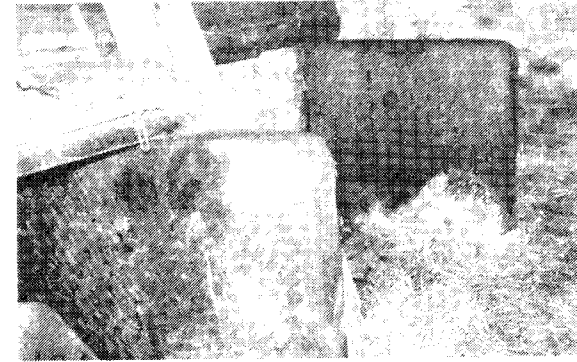
39. Cauldhame: byre with stone trevises.

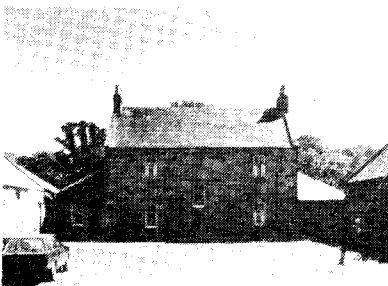
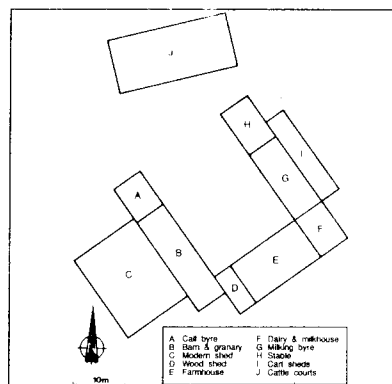
At the head of the steading is a large, very elegant, two storey farmhouse. The lower storey is of sandstone and whinstone field rubble, while the upper storey is of good quality squared sandstone rubble. The building has a slate roof and extending at right angles to the house on either side are two ranges, incorporating the major ancillary buildings. Next to the house are the old dairy and boiling house, both of which are also roofed in slate. Conveniently adjoining these is the milking byre of random rubble which now has a corrugated iron roof. The interior was modernised in the 1930s with later additions.

40. Brunton steading: northwest elevation and figure 7: plan.

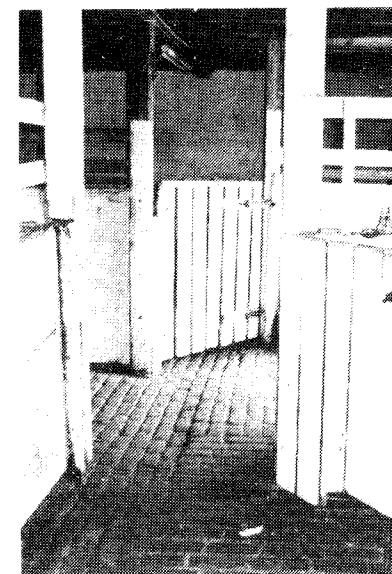
At the end of the north east range is the stable (41) with a cobbled floor and loose box. A hayloft above made feeding easier. There is also part of a stall for two pairs of horses (plus one).

41. Brunton: stable. Note the cobbled floor.
