Conservation Area Appraisal (2023)

West Lothian Council - Planning Services

1.0 Introduction to Torphichen conservation area

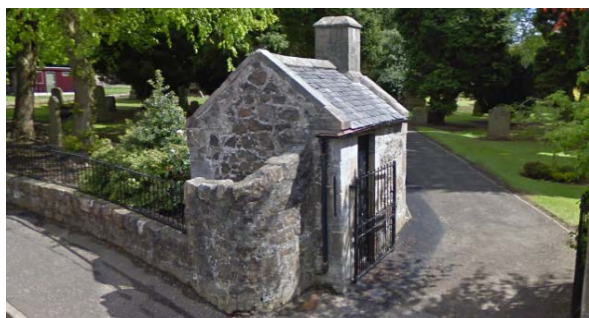
The Gatehouse was built sometime after the church but the same style and materials were used in its construction. The envelope and chimney materials consist of random rubble, and the material used for the skew-gabled roof is slate.

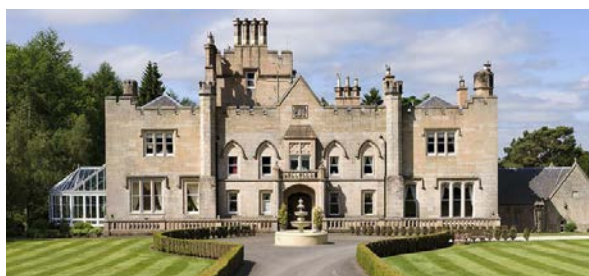
Other significant 18th century buildings in the area include the imposing Wallhouse mansion and doocot constructed during the 1840s. Originally built for the Gillon family, Wallhouse was rebuilt by James Maitland Wardrop in 1855 who added the side wings and rear tower. This category B-listed house is hidden from view behind mature dense woodland. The large castellated gothic mansion is double storey, and was built using ashlar stone for the envelope of the building, and slate for the piended (hipped) roofs, behind crenelated parapets. The central block, has 5 bays, a porch, end wings, and a rear tower. The octagonal Wallhouse doocot, is a double storey built using random rubble string-course for the envelope. The doocot is roofless, with a rounded arch entrance, and chase with hood-moulding.

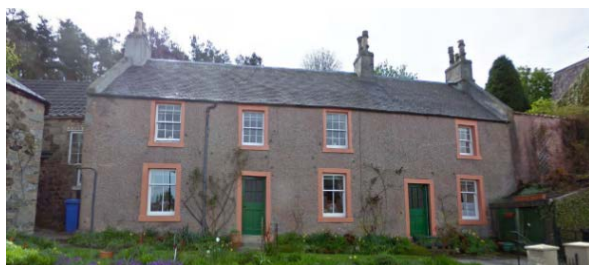
Hill House is a traditional 18th century double storey building. The building envelope was constructed using modern pebble-dash masonry, and the skew-gabled roof was constructed in slate. The building has a common terrace in the front, just off of the road. Ivy cottage is located in close proximity to hill house, and is also a traditional 18th century house. The single storey house was built using random rubble, with a lime wash finish on the front of the house. Clay Pantile was used in the construction of the skew-gabled roof.

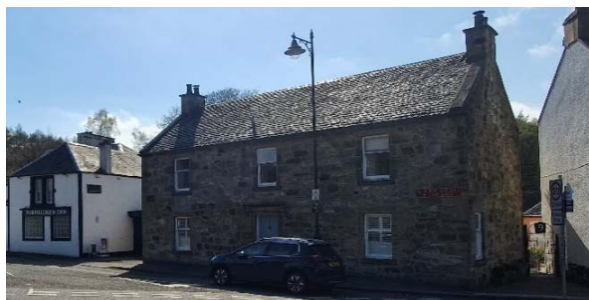
Other significant buildings in Torphichen include 5 No 19th century C listed buildings. Kirk House and Viewforth were both designed in the Georgian architectural style. Both buildings have slate skew-gabled roofs, and are both double storey houses. Kirk House was built using random rubble and has moulded door architraves, and a frieze inscribed "1802". Viewforth was constructed using Whitestone, and fillet string courses. There is a cornice above the doorway on the terrace, which is approached by steps.

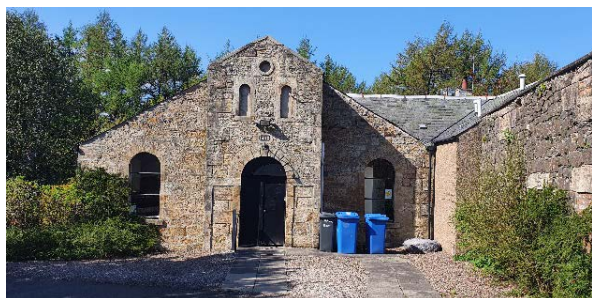
Other 19th century buildings include cottages 1-4 The Square, and Rose Cottage. Rose cottage is a single-story house which functioned previously as a smithy. The envelope of the cottage was constructed using squared rubble with flush margins. The roof of the cottage was constructed out of slate and has skews and coped end stacks. The cottage face has a centred door with an architrave, and a window on either side of the door. The wing to the left was also built with rubble and slate roof, which has a roof light. The cottage still maintains the original sashes. Cottages 1-4 The Square are traditional 1½ story cottage, with 4 dormers in the centre. The building is 4 individual properties.

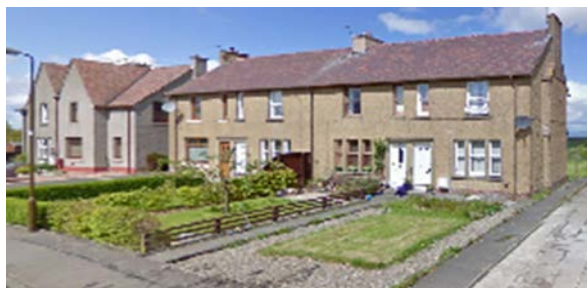
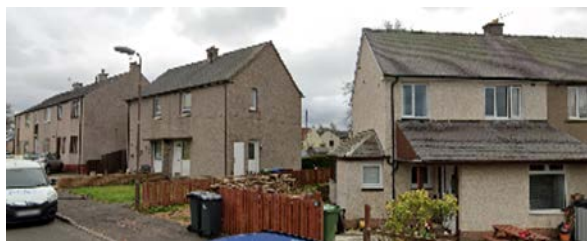
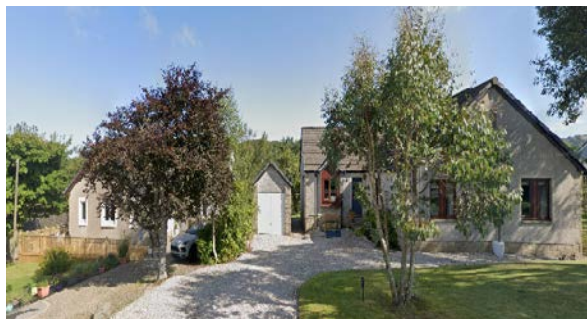
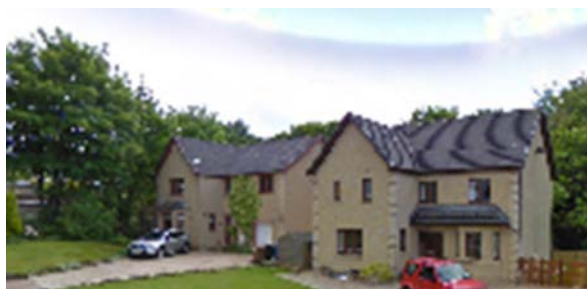
While the historic core of the village is clustered around the church and the village square, it slowly expanded northwards during the course of the 20th Century, firstly with the creation of the James Wood Park in 1922 followed by the construction of local authority housing to the north and east of it (Greenside and Bowyett) from 1945. While these houses are not architecturally distinguished in themselves, they play a role in providing the setting and character of the village and were clearly designed as such.

They do not attempt to replicate the architecture of the traditional properties in the village centre but they do nonetheless include traditional vernacular materials and details such as pitched roofs, moulded architraves and in some instances gabled dormers.

These are typified by red Rosemary Tile roofs. Such tiles are small sized, natural clay products which were commonly used as an alternative to slate on local authority and private housing. The houses are all either semi-detached or terraced and therefore roofs are shared. From an inspection it would appear that all houses still retain their original roofing materials although there is evidence, as one would expect, of patching and repair in places. Such roofs will not last indefinitely and it might be expected that over the next decades owners will wish to consider re-roofing as an alternative to patching. Patching or replacement with precisely the original material will not require planning permission but using a different material would.

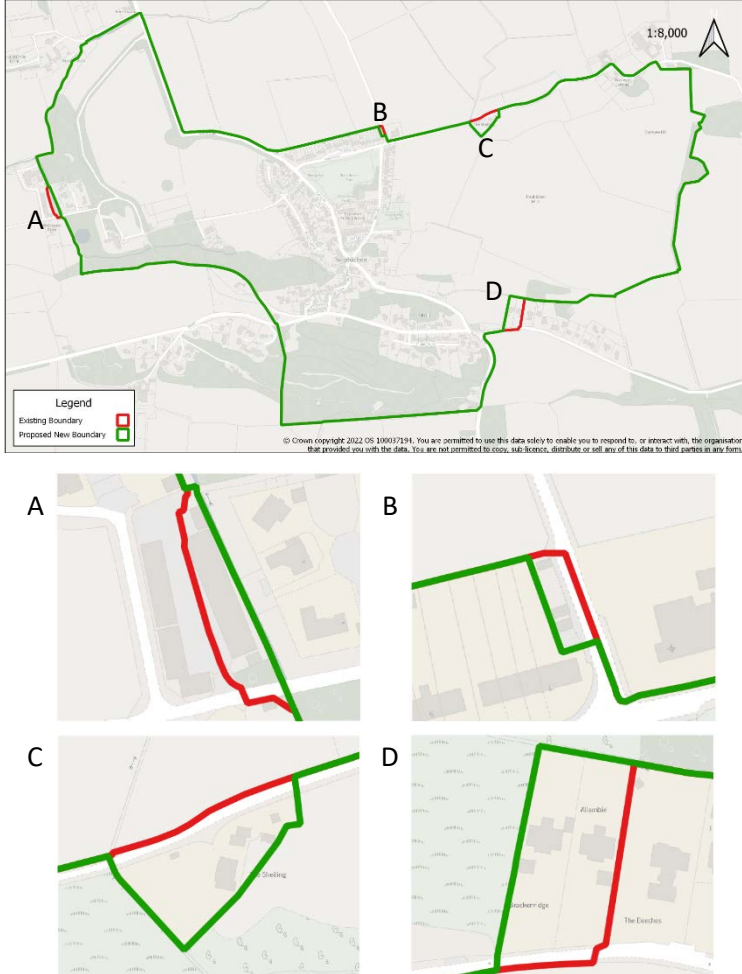
Challenges	Photographic Evidence CONSERVATION AREA BOUNDARY	Action Plan
<p>Some of the areas in the conservation area, add no significant historical, cultural or architectural significance to the area. 4 insignificant areas have been identified.</p> <ul style="list-style-type: none"> A. Agricultural shed. B. Roadside sheds for nearby residential properties. C. Unlisted residential building. D. 2 Unlisted residential buildings. <p>The accompanying map shows the proposed boundary adjustments in green, and the existing boundary in red.</p>

<p>The conservation area boundary should be adjusted to exclude these 4 areas from the Torphichen Conservation Area.</p> <ul style="list-style-type: none"> A. The conservation area boundary should be adjusted to run along the western property line to exclude the agricultural sheds. B. The conservation area boundary should be adjusted to run along the rear side of the sheds/ along the western property line of the adjacent residential property excluding the sheds. C. The conservation area boundary should be adjusted to run around the residential lot along the East, South and West property line excluding this lot. D. The conservation area boundary should be adjusted to run around the two residential lots, along the west and north property lines excluding the two lots.

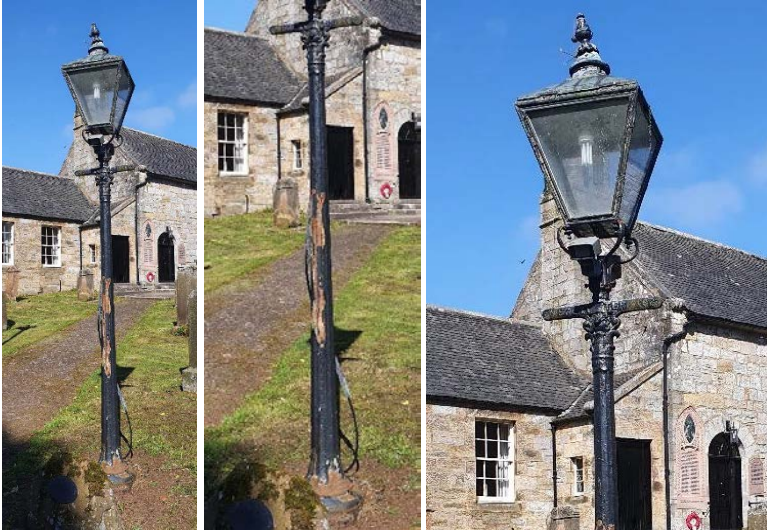
Challenges	Photographic Evidence	Action Plan
<p>On the grounds of the preceptory is a Lamp Post. The post is in a state of disrepair with flaking paint and damage to the wooden structure.</p>

<p>It is recommended the post is repaired appropriately and repainted black (preferably not high gloss).</p> <p>Alternatively, the wooden post could be replaced entirely, including an internal hollow to allow the containment of the unsightly loose cable that can be seen trailing the length of the post.</p> <p>At the time of visiting it is unclear if the Lamp is in working order. It is recommended that the lamp be repaired to full working order if so required.</p>
<p>The South window of the Preceptory is in a state of disrepair. The window is not structurally sound and is blocked off by metal fencing. due to risk of collapse, damage and/or risk of injury.</p>

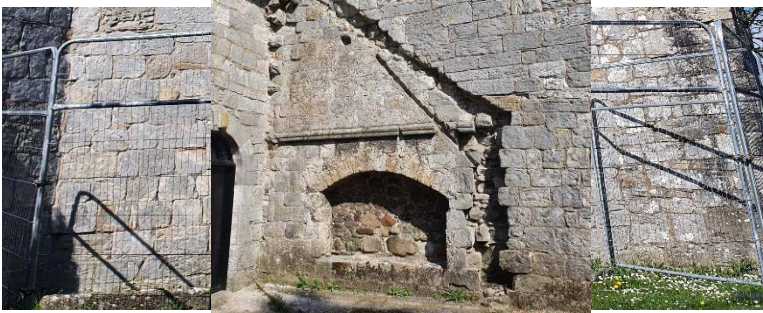
Challenges	Photographic Evidence	Action Plan
<p>The presence of the metal fencing, display the safety risks to visitors and the appearance of the building facade.</p>

<p>After repairs should be completed, the building structure of the facade, they will be visible and not obscured by the fencing. The overall appearance of the building, as well as the overall visitor experience.</p>
<p>The scarring on the East wall of the building is a result of the fire damage. This is a significant characteristic of the building and should be repaired. The East wall would benefit from repair work. The masonry/pointing has eroded away over time leaving much of the stone work open to the elements leading to further erosion and loss of stone work.</p> <p>The roof is also in need of repair. There is a single slate missing from the Southern roof gable.</p>

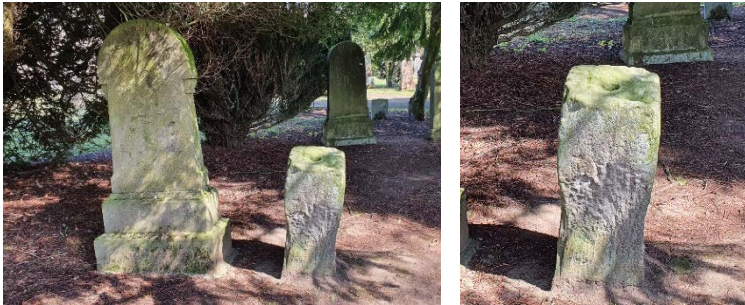
Challenges	Photographic Evidence	Action Plan
<p>The Kirkyard boundary wall (partially pictured adjoining the gatehouse) requires sporadic repairs to ensure its continued stability.</p>		<p>The boundary wall requires re-grouting with non-corrosive cement and the replacement of missing stones, works which would require scheduled monument consent from HES.</p>
<p>The Preceptory Refuge Stone is a scheduled monument located on the Preceptory grounds (but outwith the Property in Care designation) and sits beneath a mature tree, alongside a headstone as pictured.</p> <p>There is however no information about the history and significance of the refuge stone.</p>

<p>It is recommended that consideration should be afforded to setting the stone upright while appreciating that to do so would require scheduled monument consent from HES. A free-standing interpretation plaque could also be provided to explain the story and significance of the Refuge Stone, but would similarly require the consent of HES.</p>

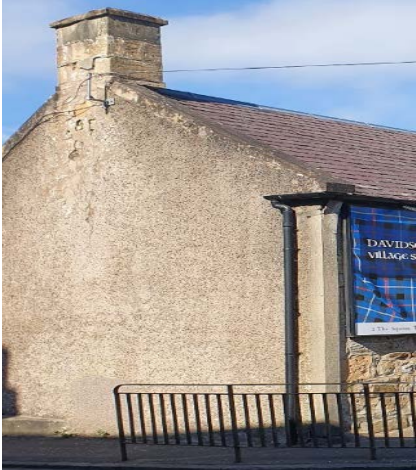
Challenges	Photographic Evidence	Action Plan
Listed Buildings and Scheduled Monuments		
<p>The village store is recognised for its value as a community asset. However the western façade of the buiding is not in a good condition. There is damage to the exterior wall & chimney where the roughcasting is flaking away & there is cracking between the brickwork.</p> <p>The stone posts standing at the entrance, are showing signs of erosion.</p> <p>The gutters are looking tacky and are in need of improvement.</p>

<p>It is recommended that the chimney is regouted using a non-corrosive material and that the roughcast is either repaired or completely removed to expose the original stonework.</p> <p>It is recommended that the worn bricks are replaced with matching counter parts of the same material.</p> <p>Gutters should be repainted and repaired where needed. The appropriate black paint should be used for this. Paint should not be high gloss.</p>

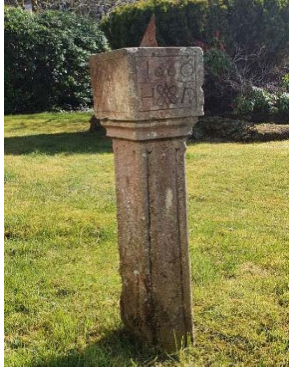
<p>Located in the garden of the private Rosebank residence, this sundial is dated from 1660 as is a category B listed building. The sundial appears in relatively good condition. Preventative erosion measures should be put in place, rather than restorative measures. There is no information available at the site of the sundial explaining its significance.</p>

<p>It is recommended action is taken to prevent any further erosion to the stone.</p> <p>Due to its location on a private property, any public information plaque must be located out with the boundaries of the residence or mounted to the exterior wall of the property, facing the public footpath.</p>

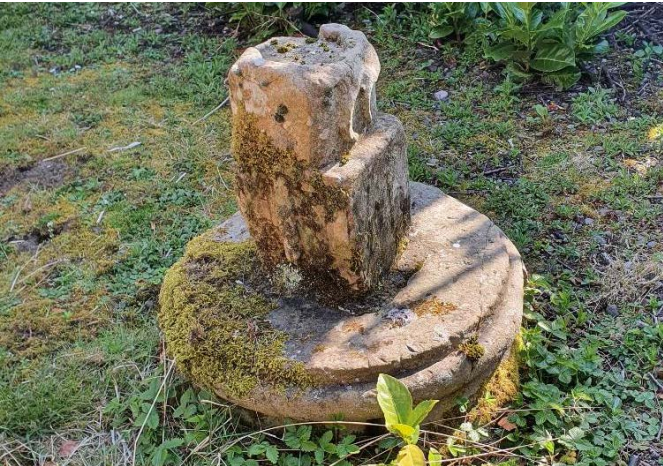
Challenges	Photographic Evidence	Action Plan
<p>Also present in this location, is a partial statue. The statue is under investigation by Historic Environment Scotland as it is believed to pre-date the sundial. It is thought to have depicted a sitting woman however it is missing the upper portion of the figurine and is significantly eroded.</p> <p>The statue is currently not listed under any designated protections, but HES has not ruled this out.</p>

<p>It is recommended that the statue is considered alongside the Sundial and that no action is taken with it until HES or the appropriate authority determine its historical significance.</p> <p>An information plaque would be an appropriate addition but it is recognised that the statue is located on a residential property. This will restrict access to the statue and the type of plaque used.</p>
Signage		
<p>The Signage on Davidsons Village Store is inappropriate for a listed building in a conservation area. The sign is out of character and is not sensitive to the building façade.</p>
