Linlithgow Public Realm Design Guide

This public realm design guide has been prepared by Brindley Associates Ltd Landscape Architects with EK:JN Conservation Architects on behalf of West Lothian Council (WLC) for Linlithgow town centre, West Lothian. This design guide focuses on the section of Linlithgow High Street between West Port and Low Port, defined by WLC as the geographical extent of the study in June 2014 see plan overleaf. Consideration is also given to public open spaces lying to the north and south of High Street at the request of WLC to include Rosemount Park, Learmonth Gardens, Regent Square, Provost Road, The Peel, Palace Rose Garden and Lochside area in accordance with the Civic Trust's 'Vision' document.

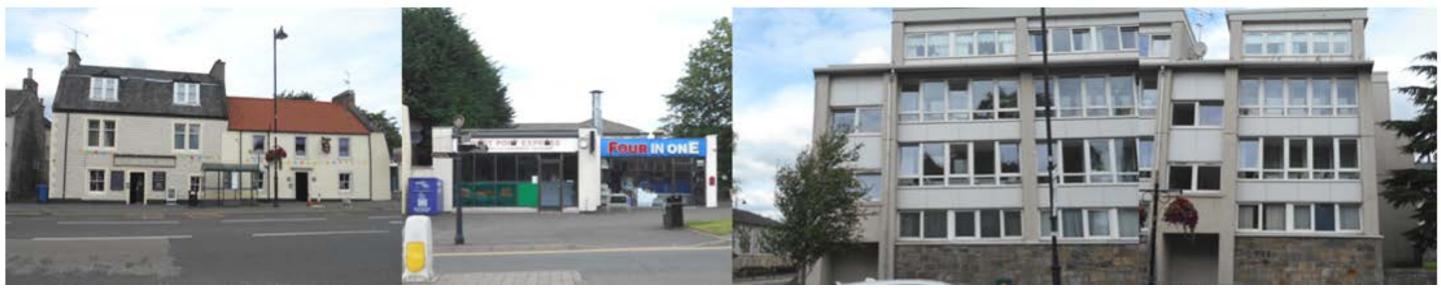
12-14 Westport: The Black Bitch Inn: Listed category C. 19th century. Ruled and lined render. Slate mansard roof.

Evidence of earlier demolished building to r.h. gable.

Leaking rainwater pipe requires attention

Non-traditional windows in No 12 should be replaced with traditional 12pane sash and case when opportunity presents.

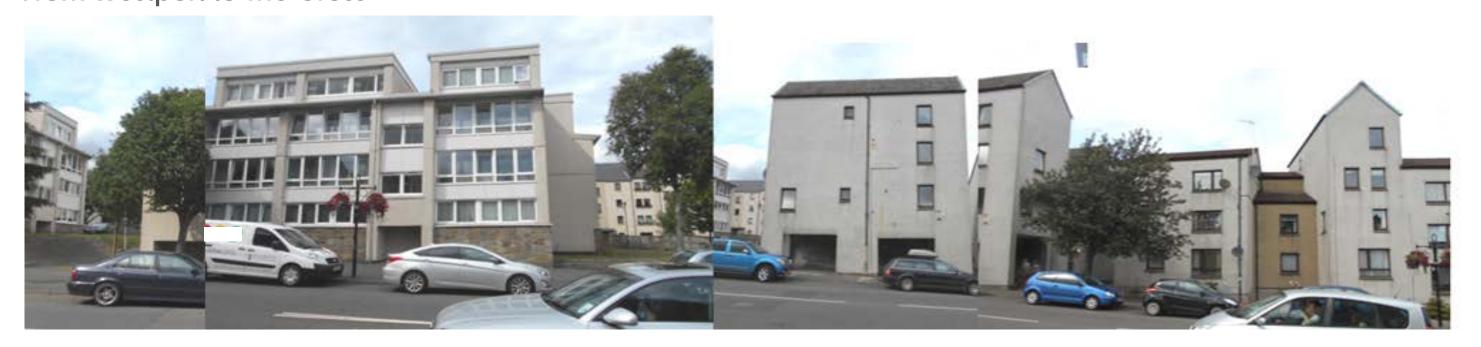
350-372 High Street: Flatted development circa 1970. Metal roof, UPVC windows.

318-348 High Street: Flatted development circa 1975. Harled walls with a mix of slate and tiled roofs. Design includes colonnade over the pavement, historically a common feature of Linlithgow High Street largely lost by 1900.

Some repairs to rainwater goods and harling would improve this facade. Proliferation of satellite dishes is regrettable and visually distracting

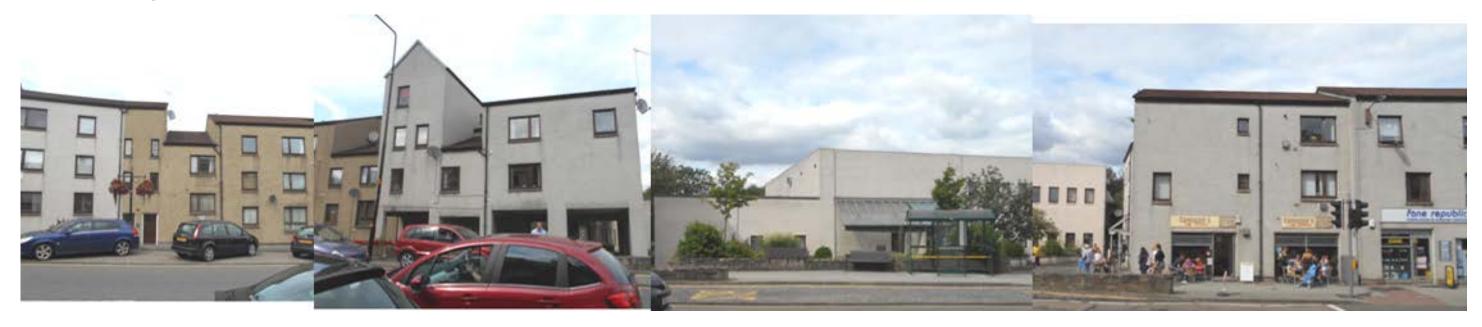
290-316 High Street: Flatted development circa 1975. Harled walls with tiled roofs, with slate on the 4-storey block. Design includes colonnade over the pavement, historically a common feature of Linlithgow High Street largely lost by 1900.

Some repairs to rainwater goods and harling would improve this facade. Proliferation of satellite dishes is regrettable and visually distracting. The modern buildings in this area followed slum clearance in the 1960s, with significant loss of historic townscape. The redevelopment of this area also removed disused tanneries that occupied the land between High Street and Linlithgow Loch. 286,288 High Street: Linlithgow Health Centre 264-284 High Street: Retail/Flatted development circa 1975. Harled walls, tiled roofs.

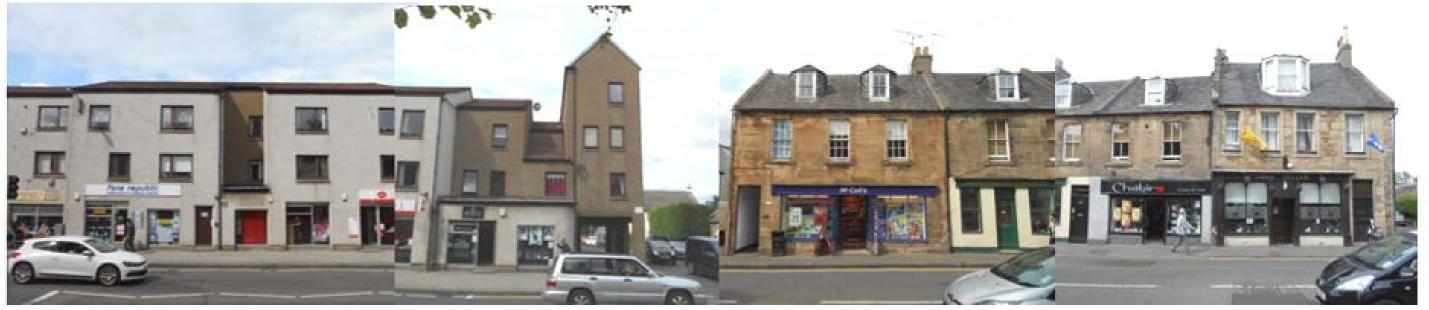
264-284 High Street: Retail/flatted development circa 1975. Harled walls. Tiled roofs, with slate on the 4storey block. Design includes a colonnade. At the Water Yett.

Proliferation of satellite dishes is regrettable and visually distracting.

Salt damaged stonework, r.h. base

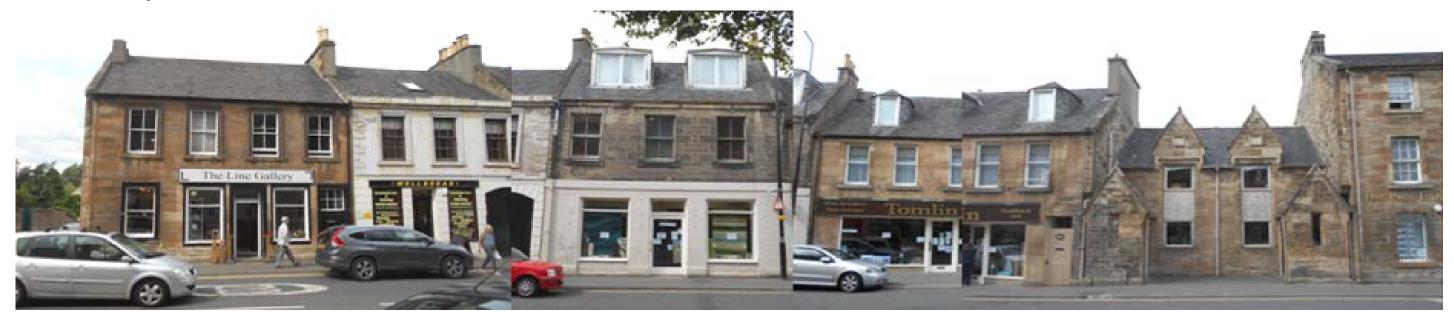
238 High Street: Listed category C. Early 19th century. Asymmetrical ground and. Regular but asymmetrical first floor. Sandstone walls, slate roof. Traditional 4-pane sash and case windows.

Missing chimney pots. Weeds growing at roof level.

Salt damaged stonework under windows.

232-236 High Street: Listed category B. Early 19th century. Asymmetrical ground floor. Symmetrical first floor. Central parapet apex (compare to 257 High Street) Arched carriage pend. Painted sandstone walls, slate roof. Traditional 12-pane sash and case windows stained brown.

Leaking rhone, r.h end

First floor windows, right and centre are new in heritage colours, but left is in need of matching replacement.

Salt-damaged stonework below windows.

Plastic rainwater hopper should be replaced with cast iron. 226-228 High Street: Note the rounded front dormers.

UPVC windows in dormers should be replaced with traditional 12-pane sash and case when opportunity presents. Fa ea Frc of Re wi be ch

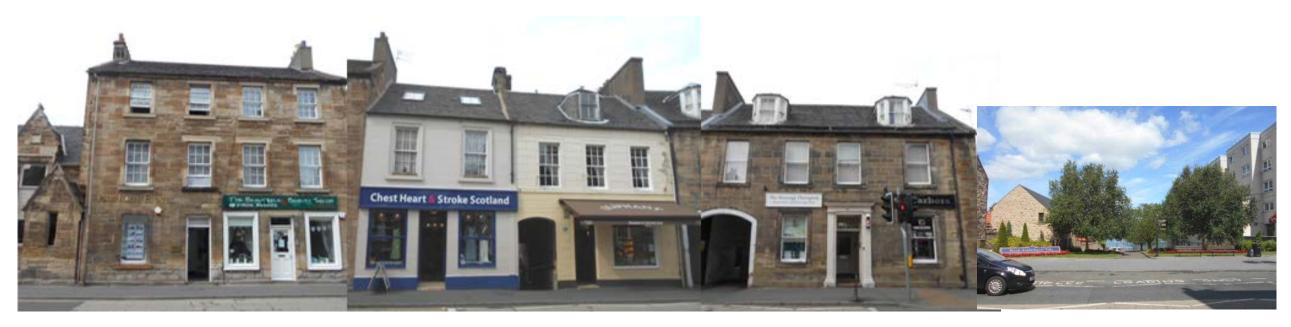
222,224 High Street: Listed category C. Early 19th century. Asymmetrical ground floor. Symmetrical first floor. Upper storey windows are smaller.

Salt-damaged stonework below windows

Leaking rainwater pipe.

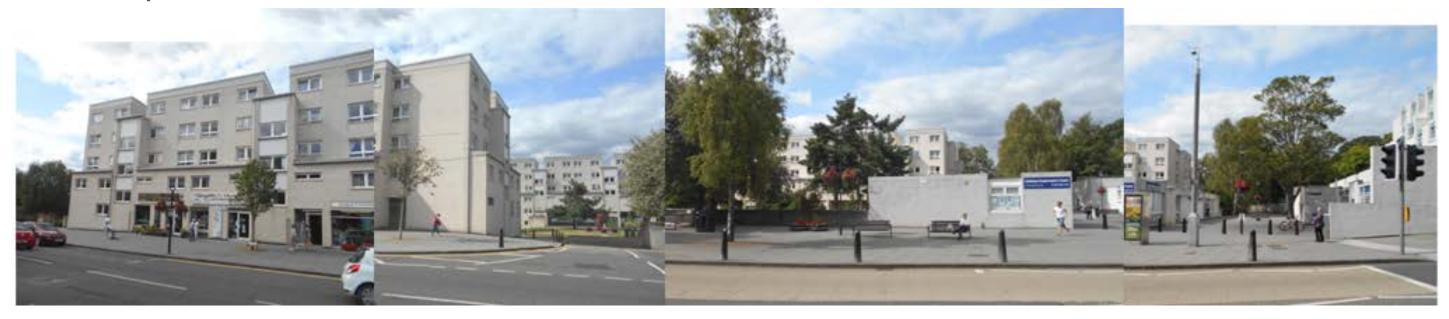
56-99 The Vennel: Retail and flatted development circa 1970. Harled walls, flat roof.

Weeds growing on various ledges and roofs.

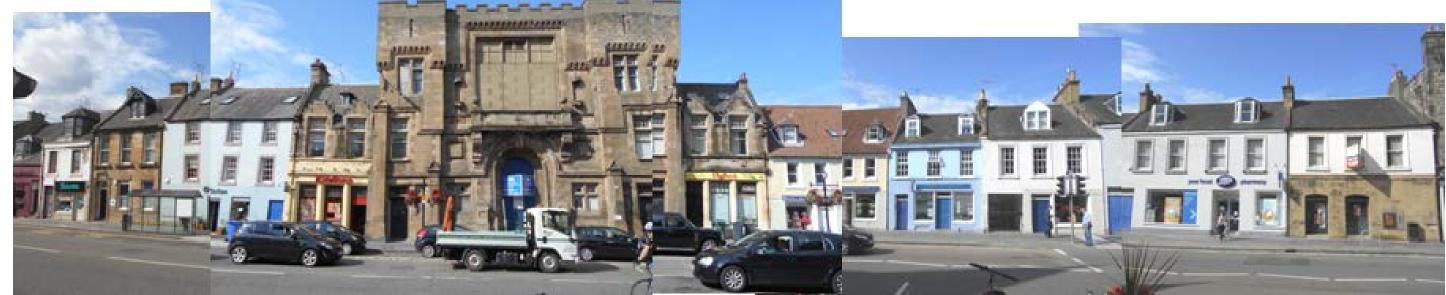
100 High Street: Listed category C. Early 19th century. Sandstone walls, slate roof. Asymmetrical ground floor, symmetrical upper. Traditional sash and case windows. Ornate projecting sills on upper floor.

Some evidence of weathered stonework and lintels out of true.

Leaking rainwater pipe

Stonework badly weathered. West tower leaning westward. Rainwater pipes absent or leaking.

Leaking rainwater pipes and corroded cellar grating.

Poor quality top-hung windows would benefit from replacement with traditional 12-pane sash and case.

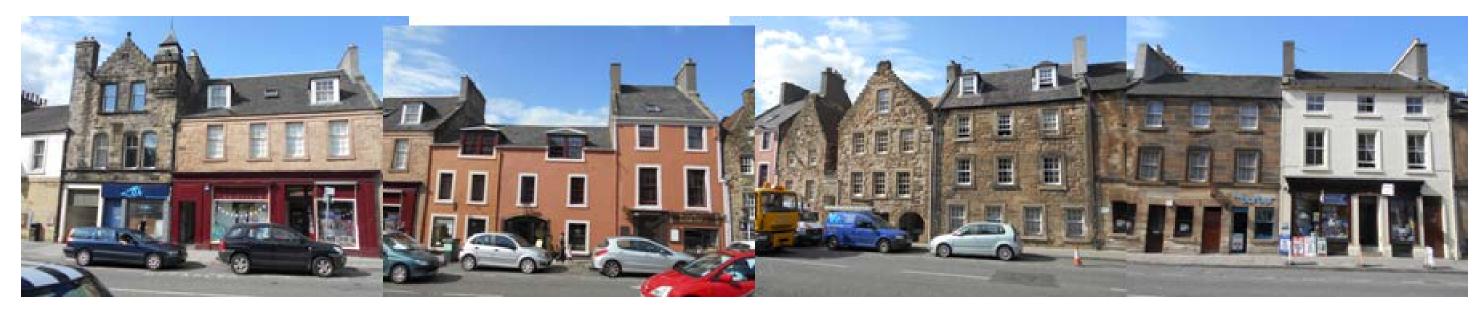
62-64 High Street: Listed category C. Carved date stone 1881.

Salt-damaged stonework at base

Salt-damaged stonework at base.

Leaking rainwater pipe r.h.end

Missing chimney cans l.h.

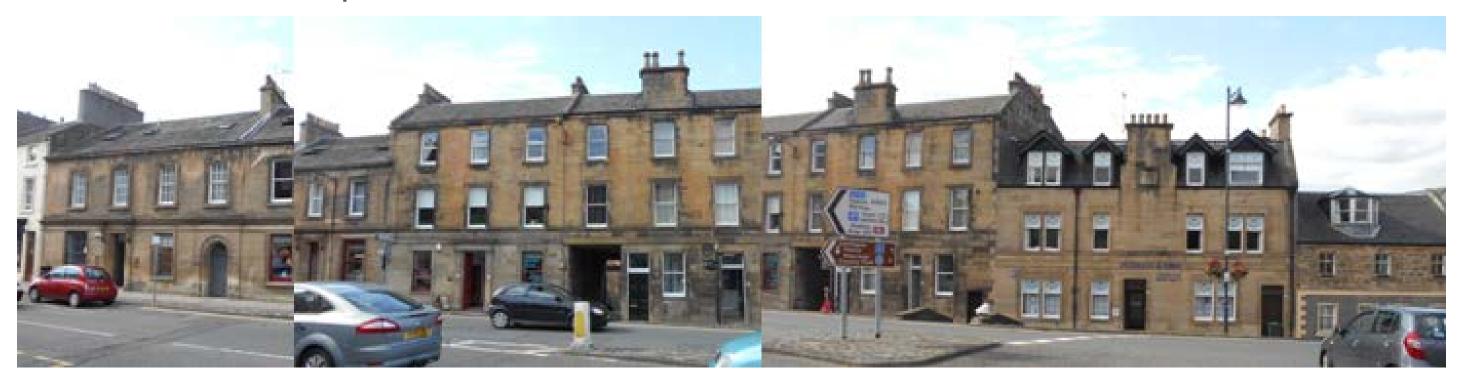
20-24 High Street: Listed category B. Circa 1840. 7-bay facade with arched central pend. Sandstone and slate roof. Asymmetrical ground floor and symmetrical upper. Some 12-pane and some 2-pane windows, traditional sash and case.

Salt-damaged stonework at base.

Missing chimney cans.

Salt-damaged stonework under windows.

Leaking and absent rainwater pipes.

d	2,4 High Street: Listed category C. Early 19 th century. Harling and Sandstone. Near symmetrical, apart from dormer which is off-centre.
e	Unusual decorative margins to ground floor windows.
ks	Leaking rainwater pipe, r.h. end

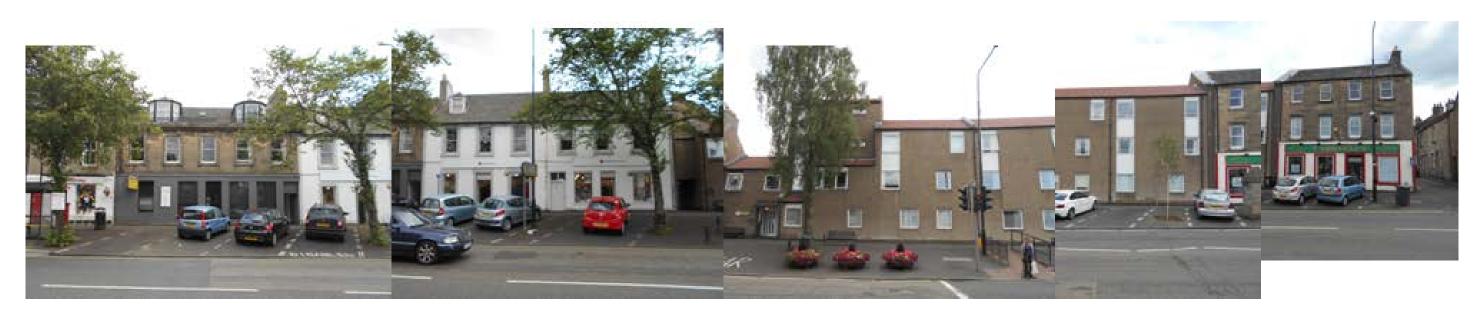
213-215 High Street: Listed category B. Built 1844. Asymmetrical ground floor, symmetrical upper floor. Sandstone, slate roof.

Currently vacant (2014) with unused bracket for projecting sign.

Leaking rhone and downpipe

245 High Street: 19th century. Asymmetrical ground floor, symmetrical upper floors. Sandstone, slate roof. Chimney stack missing I.h.

First floor windows are non-traditional UPVC. Could be replaced with traditional 12pane sash and case windows if opportunity presents.

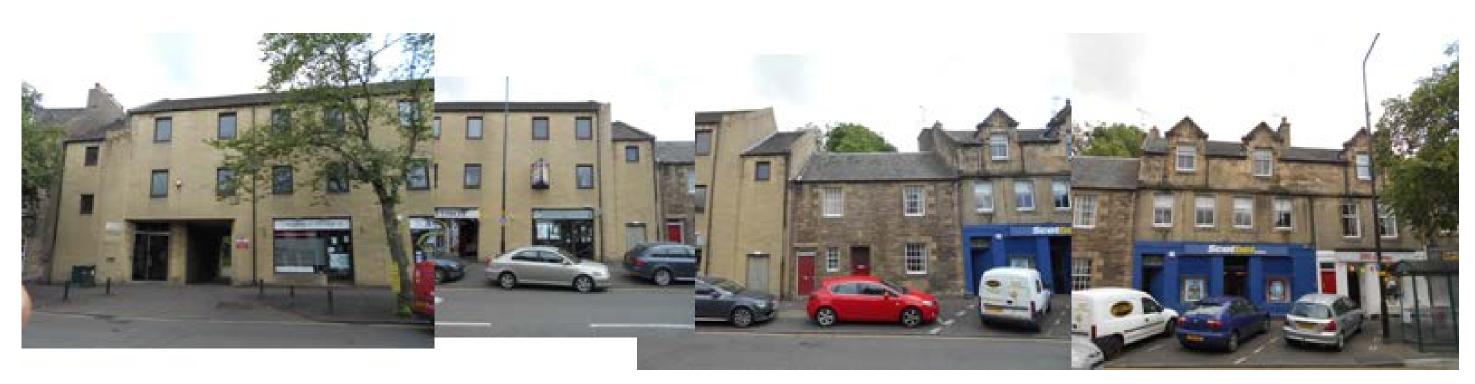
181-187 High Street: Circa 1980. Offices and retail.

Rainwater pipe damaged and leaking r.h. side.

Rainwater pipe missing an access cover, centre

Rainwater pipe leaking.

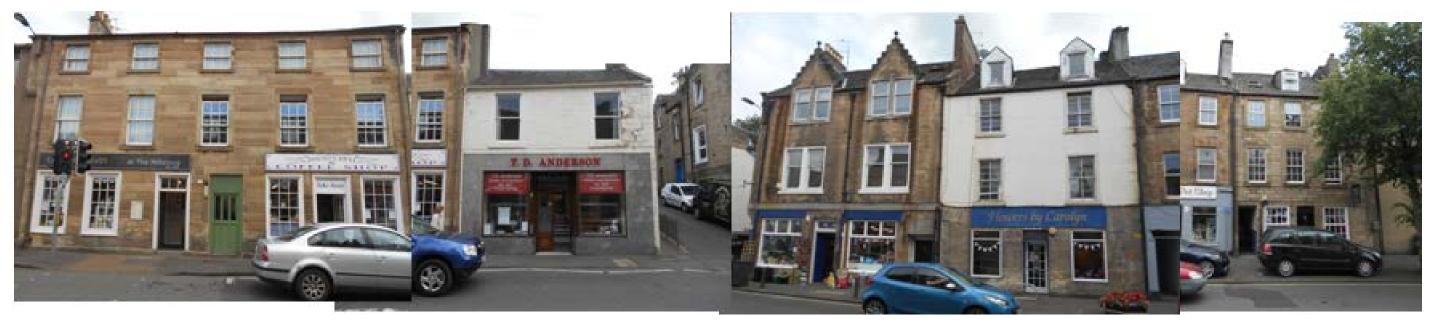
161High Street: Listed category C. Asymmetrical ground floor, symmetrical upper floors. Sandstone, slate roof. Traditional 12-pane sash and case windows, smaller on top storey. 1nr projecting sign. Mansard roof.

Inappropriate metal door to central pend is out of character.

Leaking rainwater pipes.

Top floor windows are non-traditional UPVC. Could be replaced with traditional 12-pane sash and case windows if opportunity presents.

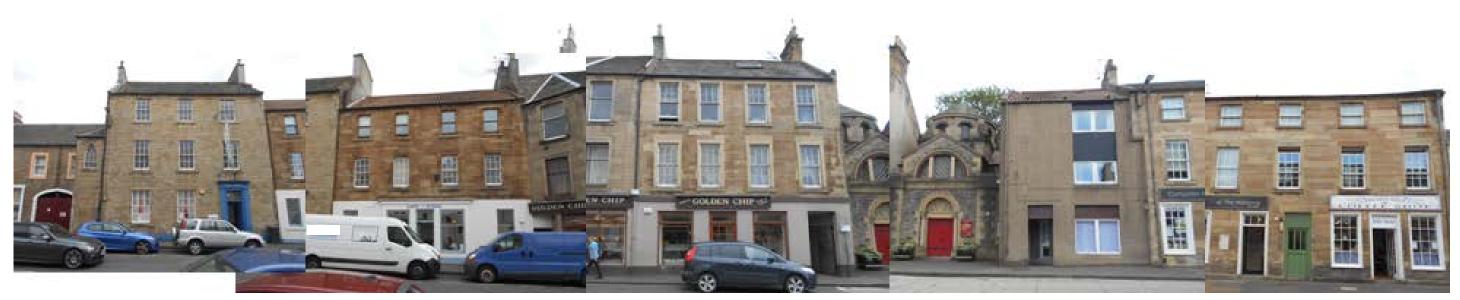
143 High Street: Listed category B. Annet House. 18th century merchant's house. Asymmetrical grounds floor, symmetrical upper. Sandstone, Slate roof. Traditional 12-pane sash and case windows, smaller on top storey.

145 High Street: Listed category C. 19th century. Symmetrical facade. Sandstone, Pantiled roof with slate easing course. Windows smaller on top storey.

Leaking rainwater pipe.

Top storey Windows might be replaced with 12-pane sash if opportunity presents.

Windows might be replaced with 12-pane sash and case to match 149 if opportunity presents.

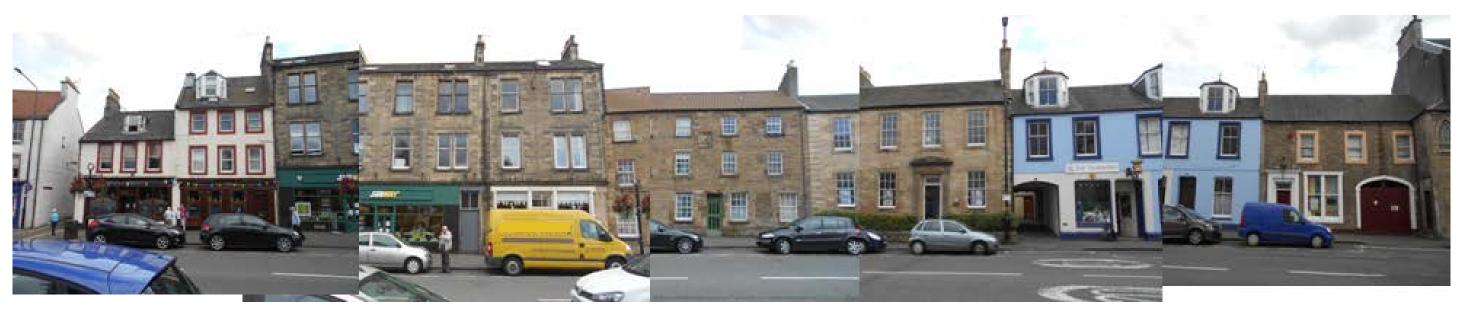
111,113,115 High Street: Listed category C. Football & Cricketers Inn. Circa 1800. Asymmetrical façade, rendered, lined and painted. Slate roof. Unused cast iron hanging sign bracket.

Dormers in need of maintenance.

Leaking rhone and rainwater pipe.

Modern metal entrance door is out of character. Consider replacement if opportunity presents. 129 High Street: Listed category B. Built 1829. Asymmetrical ground floor, symmetrical upper. Sandstone, Slate roof.

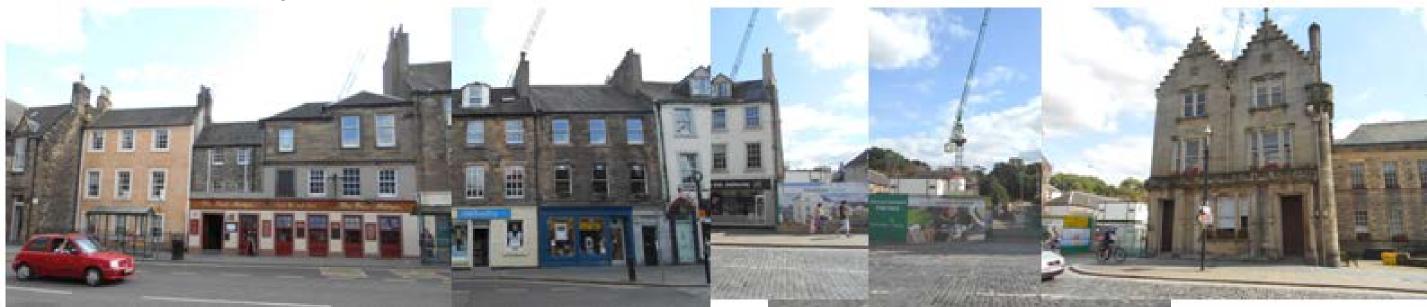
63 High Street: Listed category B. Late 18th century. Asymmetrical ground floor, Near symmetrical upper. Coloured harling walls, with slate roof. Traditional 12-pane sash and case windows, top storey windows smaller. Reproduction metal railings at road boundary.

Traditional timber shopfront requiring maintenance r.h. end to prevent loss of detailing. Detail already lost I.h end. Shopfront improvement grant could help to repair this.

Leaking rhones.

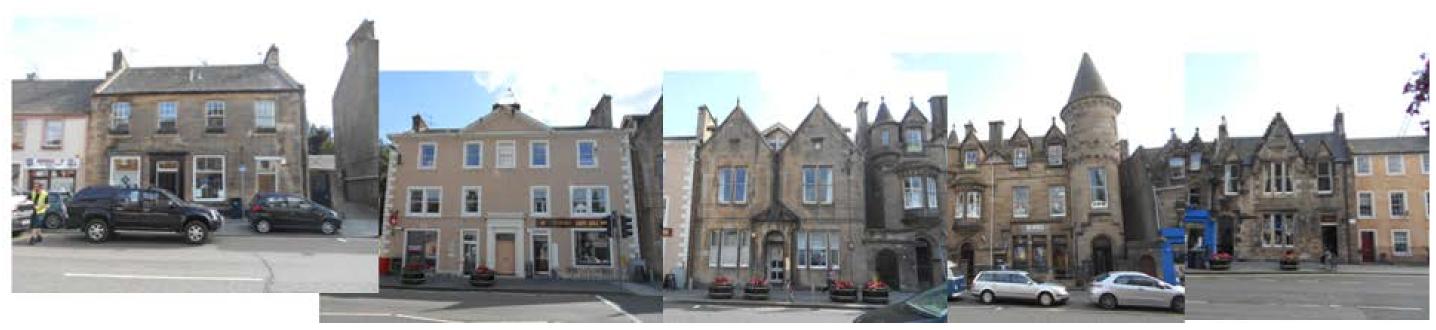
39-41 High Street: Listed category B. Early 19th century. Asymmetrical ground floor, symmetrical upper. Sandstone, Slate roof. Traditional sash and case windows, 6+1. 1nr projecting sign.

Leaking rainwater pipe

Pediment and cornice in need of repair and maintenance

Missing chimney cans.

Leaking rhone in centre causing staining. Possibly hopper blocked with weeds. Plastic hopper should be replaced wit cast iron.

Leaking rainwater pipe. Appendix 1 Page 27

White plastic pipework on the facade is intrusive and should be replaced with cast iron, painted to match stone. 59-61 High Street: Listed category C. Asymmetrical ground floor, symmetrical upper. Sandstone, Slate roof. Carved date plaque 1870. Carved stone from earlier building dated 1527. Arched pend with metal gate. Projecting sign (not consented)

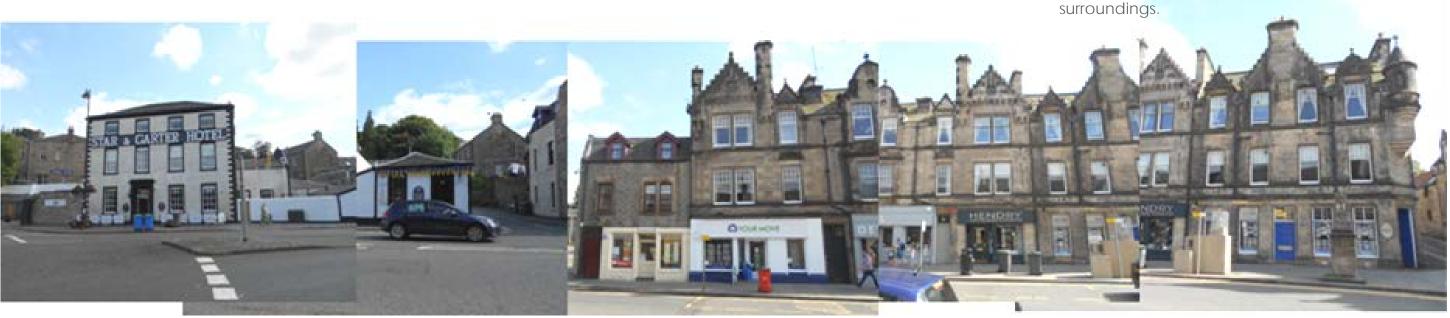
1 High Street: Listed category B. Star & Garter Hotel. Built as provost's residence in 1760. Gutted by fire in 2010. Restored and reopened 2014. Harled walls with painted details. Slate roof. Traditional 12-pane sash and case windows. Asymmetrical ground floor. Symmetrical upper. Projecting sign and flagpoles.

Leaking rainwater pipes.

Salt-damaged stonework at base. St Michael's Well: Listed category A. Standing in front of 21 High Street. Dated 1720, with carved St Michael holding Linlithgow coat of arms. Inscribed "St Michael is kynd to strangers". Restored 2010.

Leaking rainwater pipe.

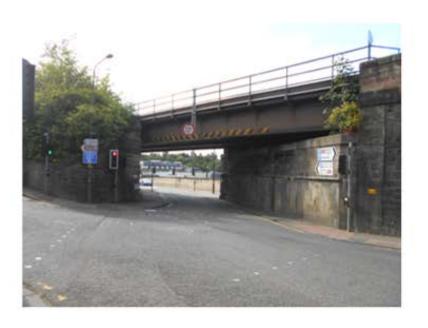
This entrance to the town from Edinburgh Road is in poor condition. Weeds growing in the stonework, utilitarian signage, poor paint finish, soiled and stained stonework. No clear indication of which way to go to enter the town centre.

From Lowport to Highport. This area has suffered from lack of attention for many years.

Rear wall of the service yard for Tesco is in need of routine maintenance. The railway bridge heading out towards Edinburgh Road could be much improved, and the historic gateway which once led into the Nobel factory is in need of maintenance. Weeds growing in the Nobel gateway and on the stonework of the railway bridge.

Opportunities may exist for a better welcome to the town centre at this point.

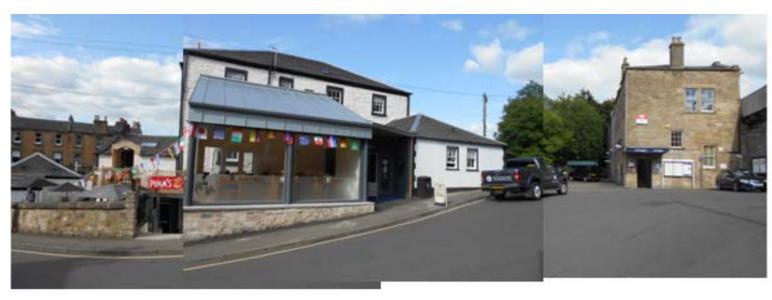
Recent extension to the rear of the Star & Garter Hotel. Railway Station: Listed category C Constructed 1842. Altered 1870 and 1986. Snecked sandstone.

Some weeds growing on ledges

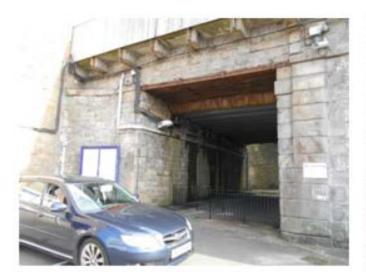
Underpass recently cleaned.

No signage linking town centre to canal basin. Opportunity for significant improvement to this route.

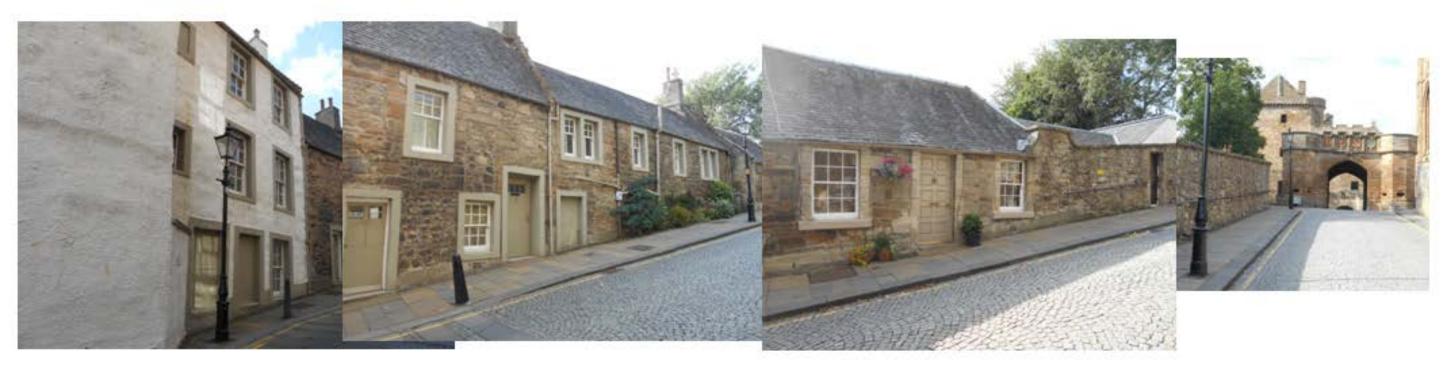
Kirkgate

2 Kirkgate: Listed category B. Asymmetrical cottage façade. Circa 1700. Sandstone, slate roof Good use of heritage colours.

Leaking drainage pipes.
